Todd BenDor
bendor@unc.edu

Sub-Watershed and Stream Evaluation

Thinking about Sub-watersheds

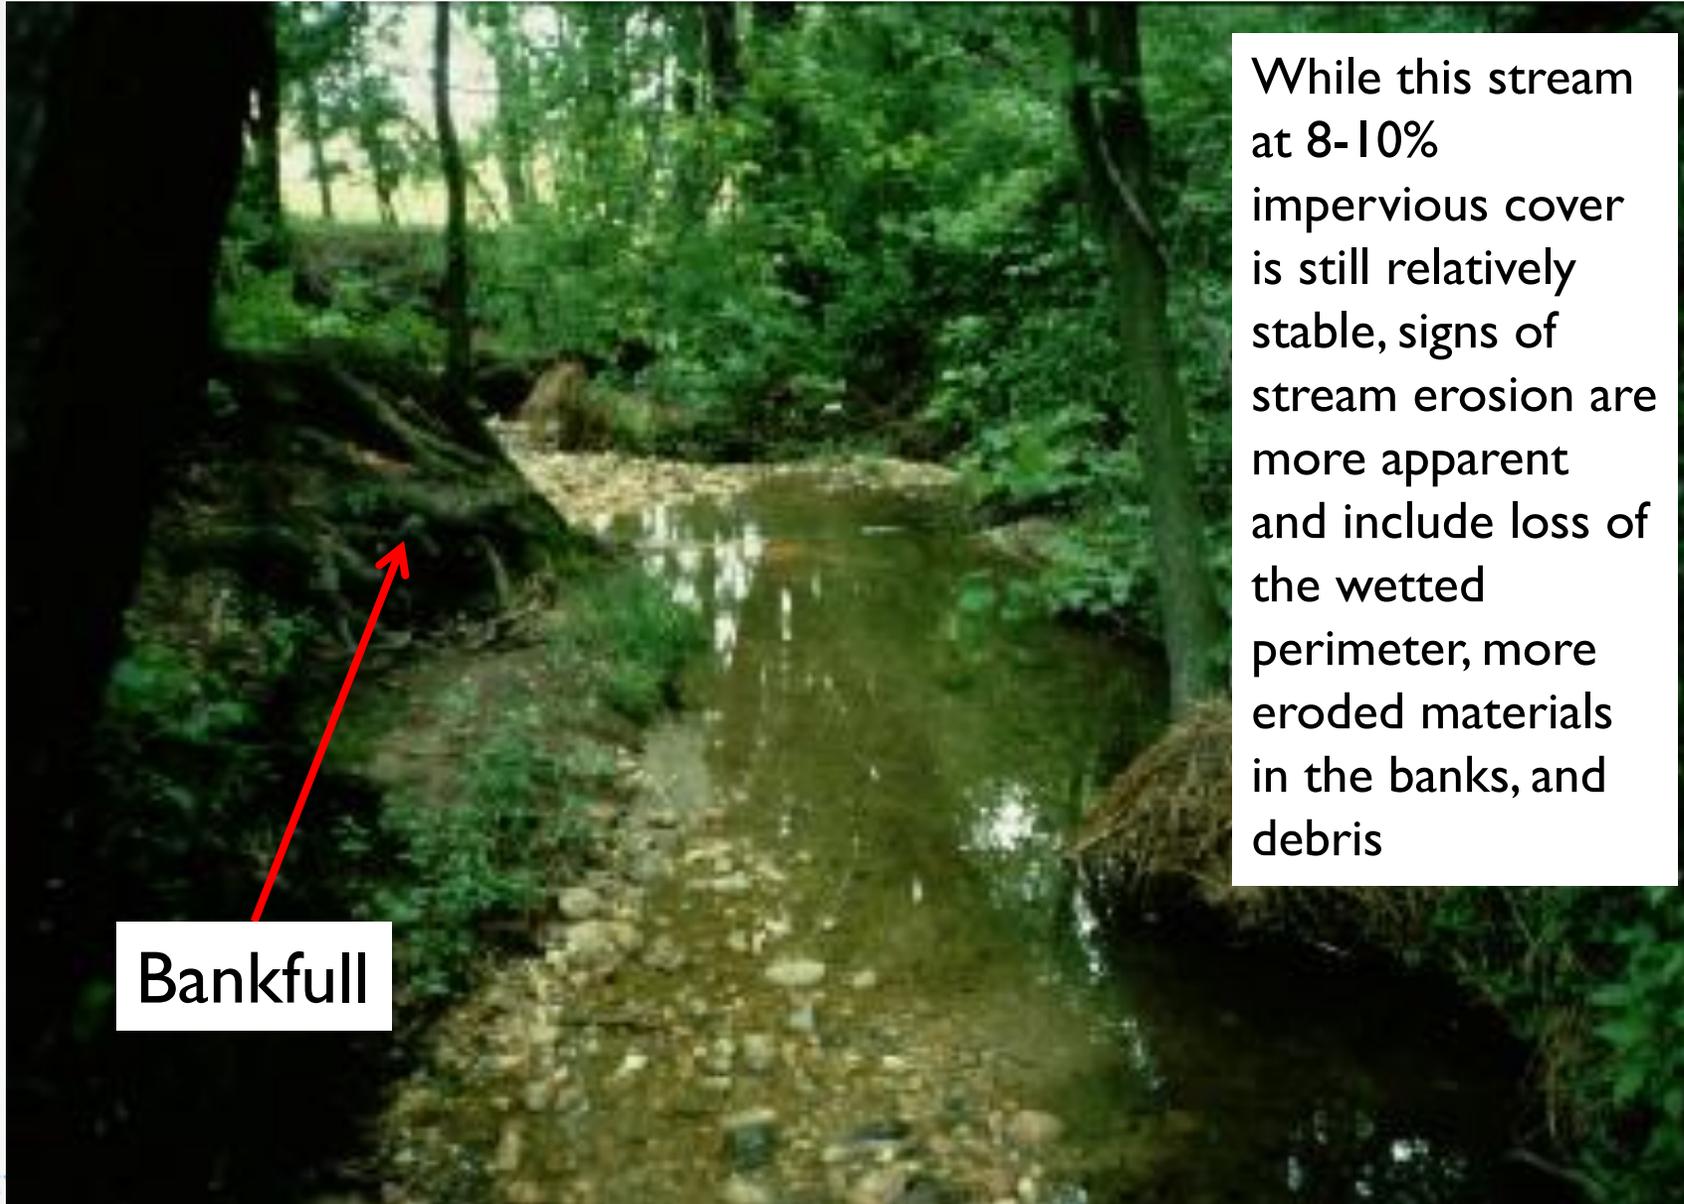
While this stream at 8-10% impervious cover is still relatively stable, signs of stream erosion are more apparent and include loss of the wetted perimeter, more eroded materials in the banks, and debris

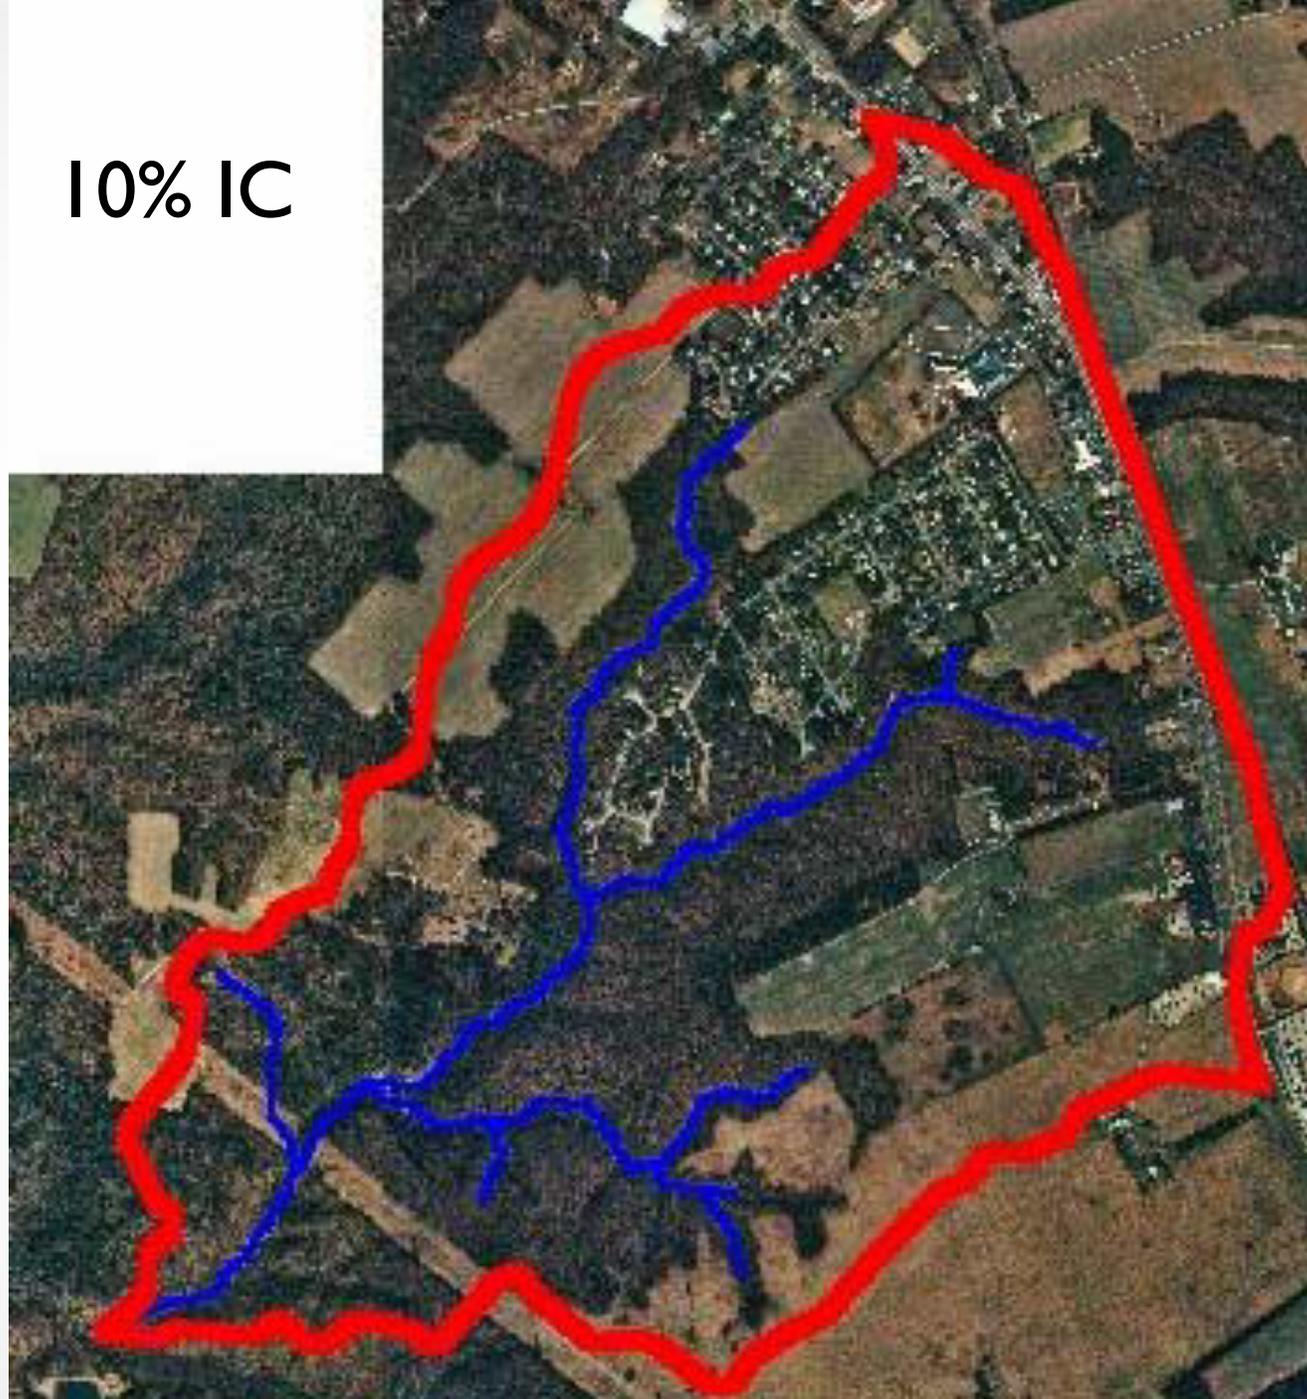
10% IC

At 10%, impervious cover, the stream is slightly more visibly impacted. The stream shown here has approximately doubled its original size, tree roots are exposed, and the pool and riffle structure seen in sensitive streams is lost.

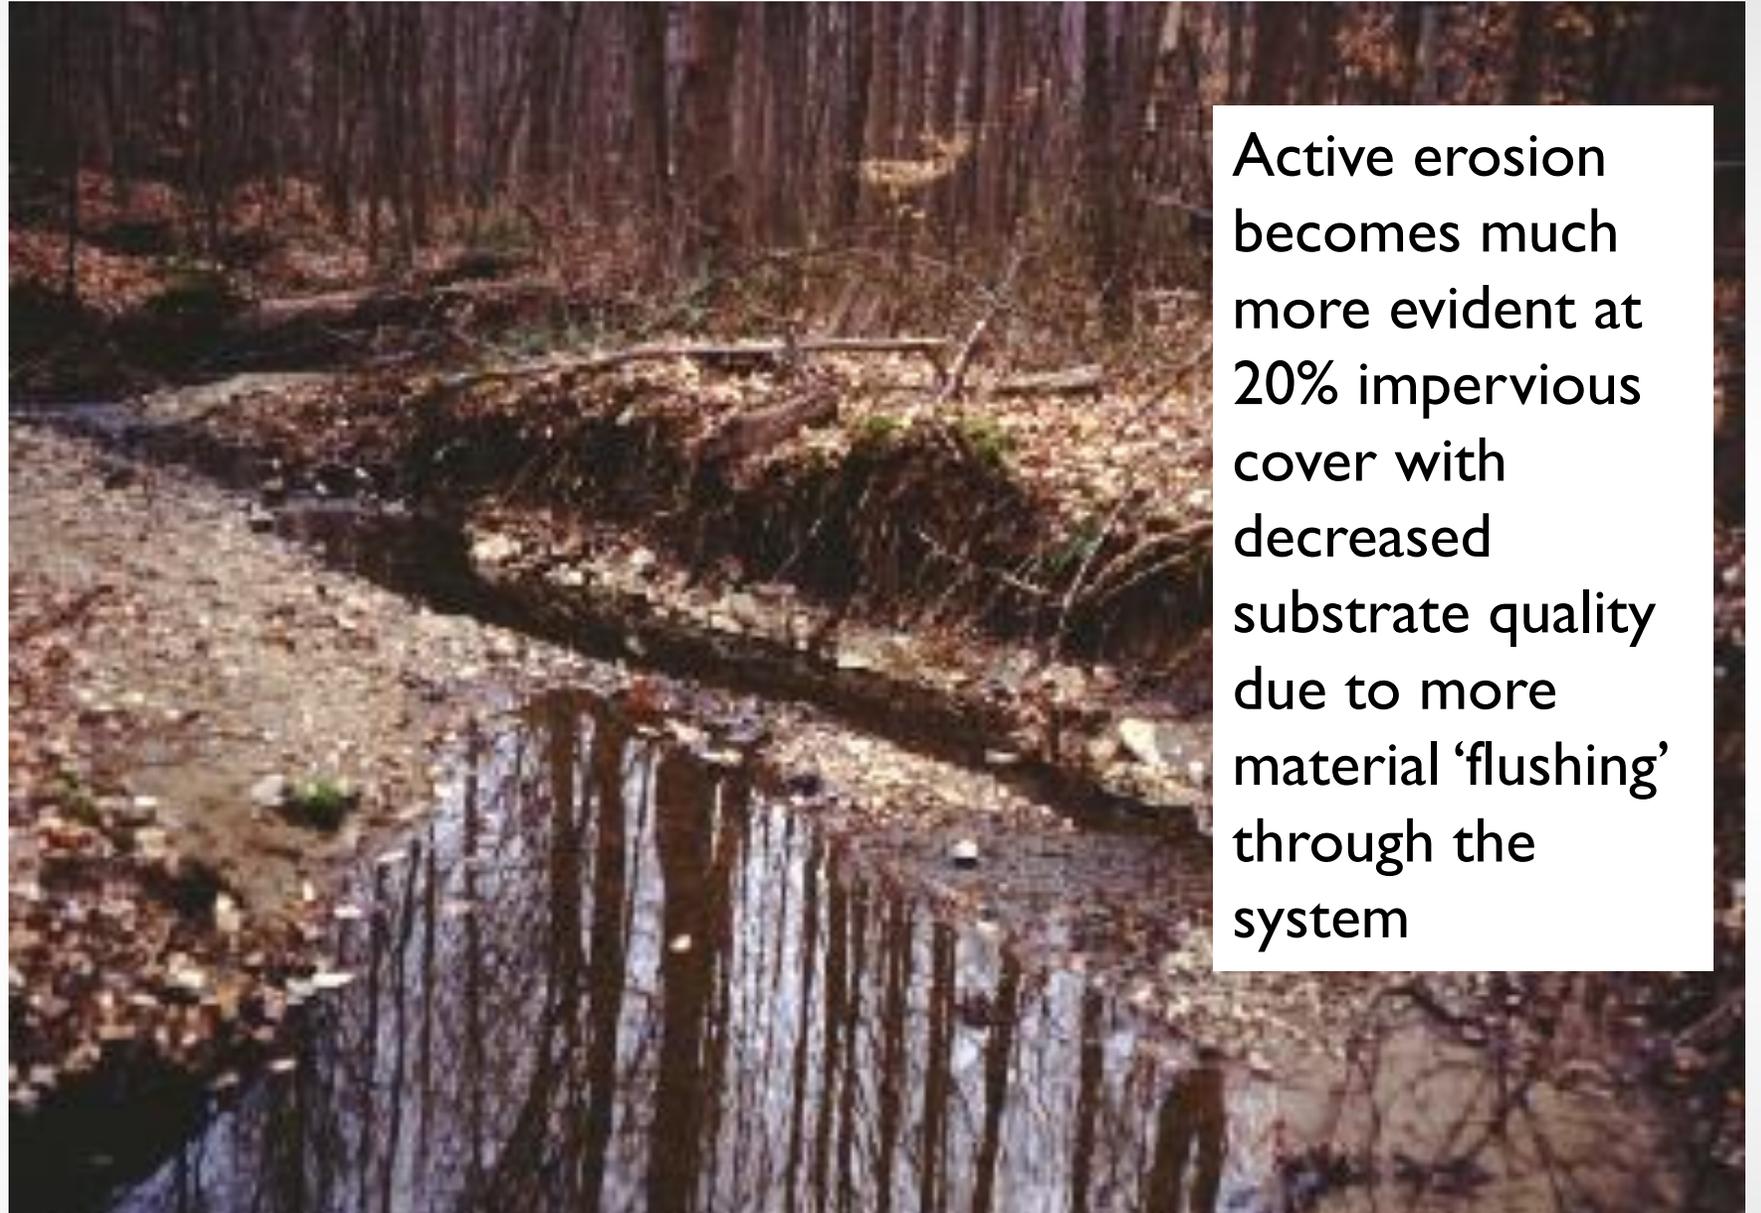
Active erosion becomes much more evident at 20% impervious cover with decreased substrate quality due to more material 'flushing' through the system

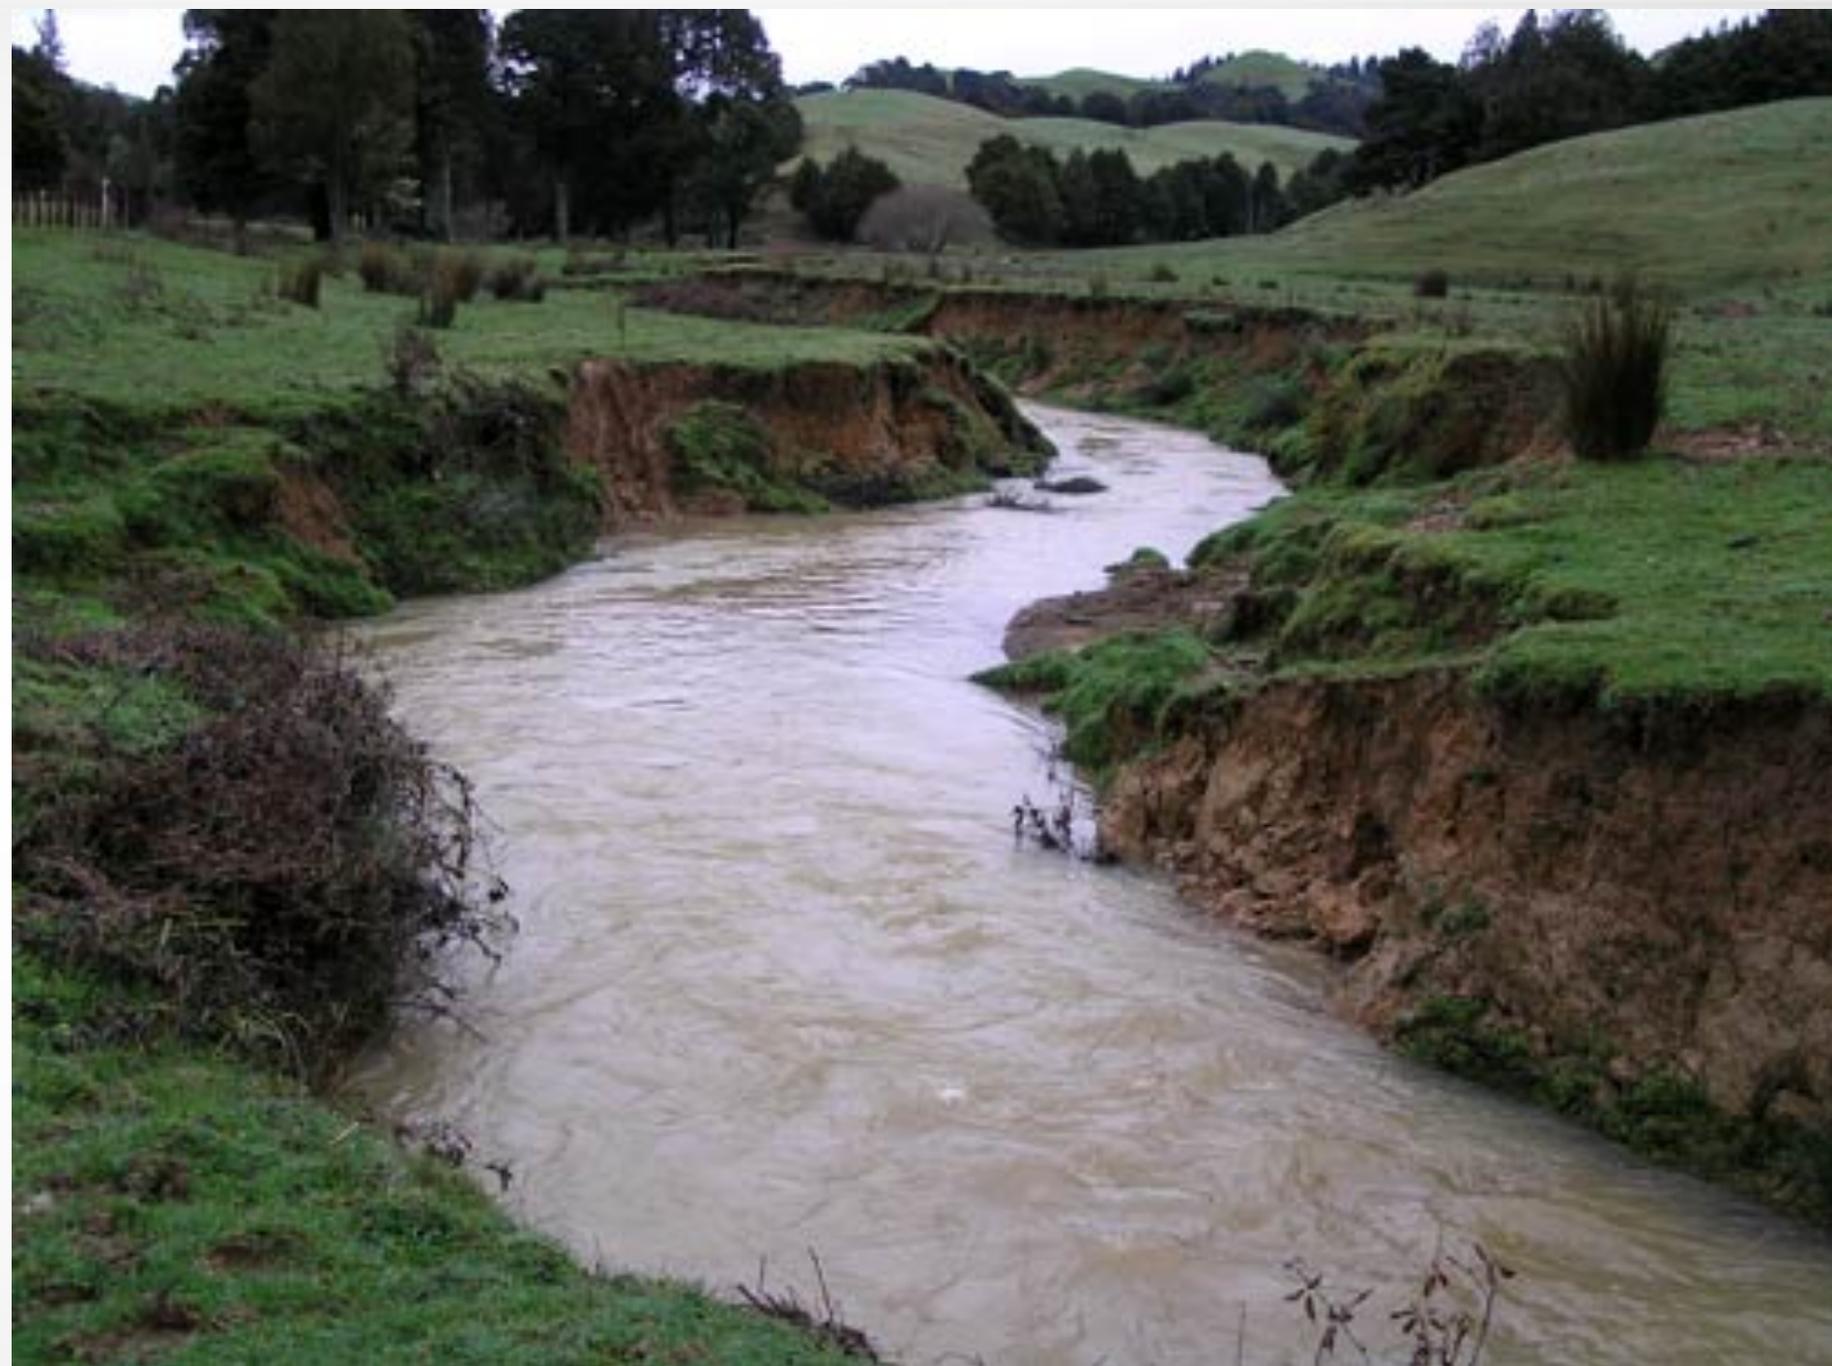
The surrounding area of this stream is also approximately 20% impervious cover and shows stream erosion that is much worse than in the previous slide due to an absence of vegetation to hold together bank structure.

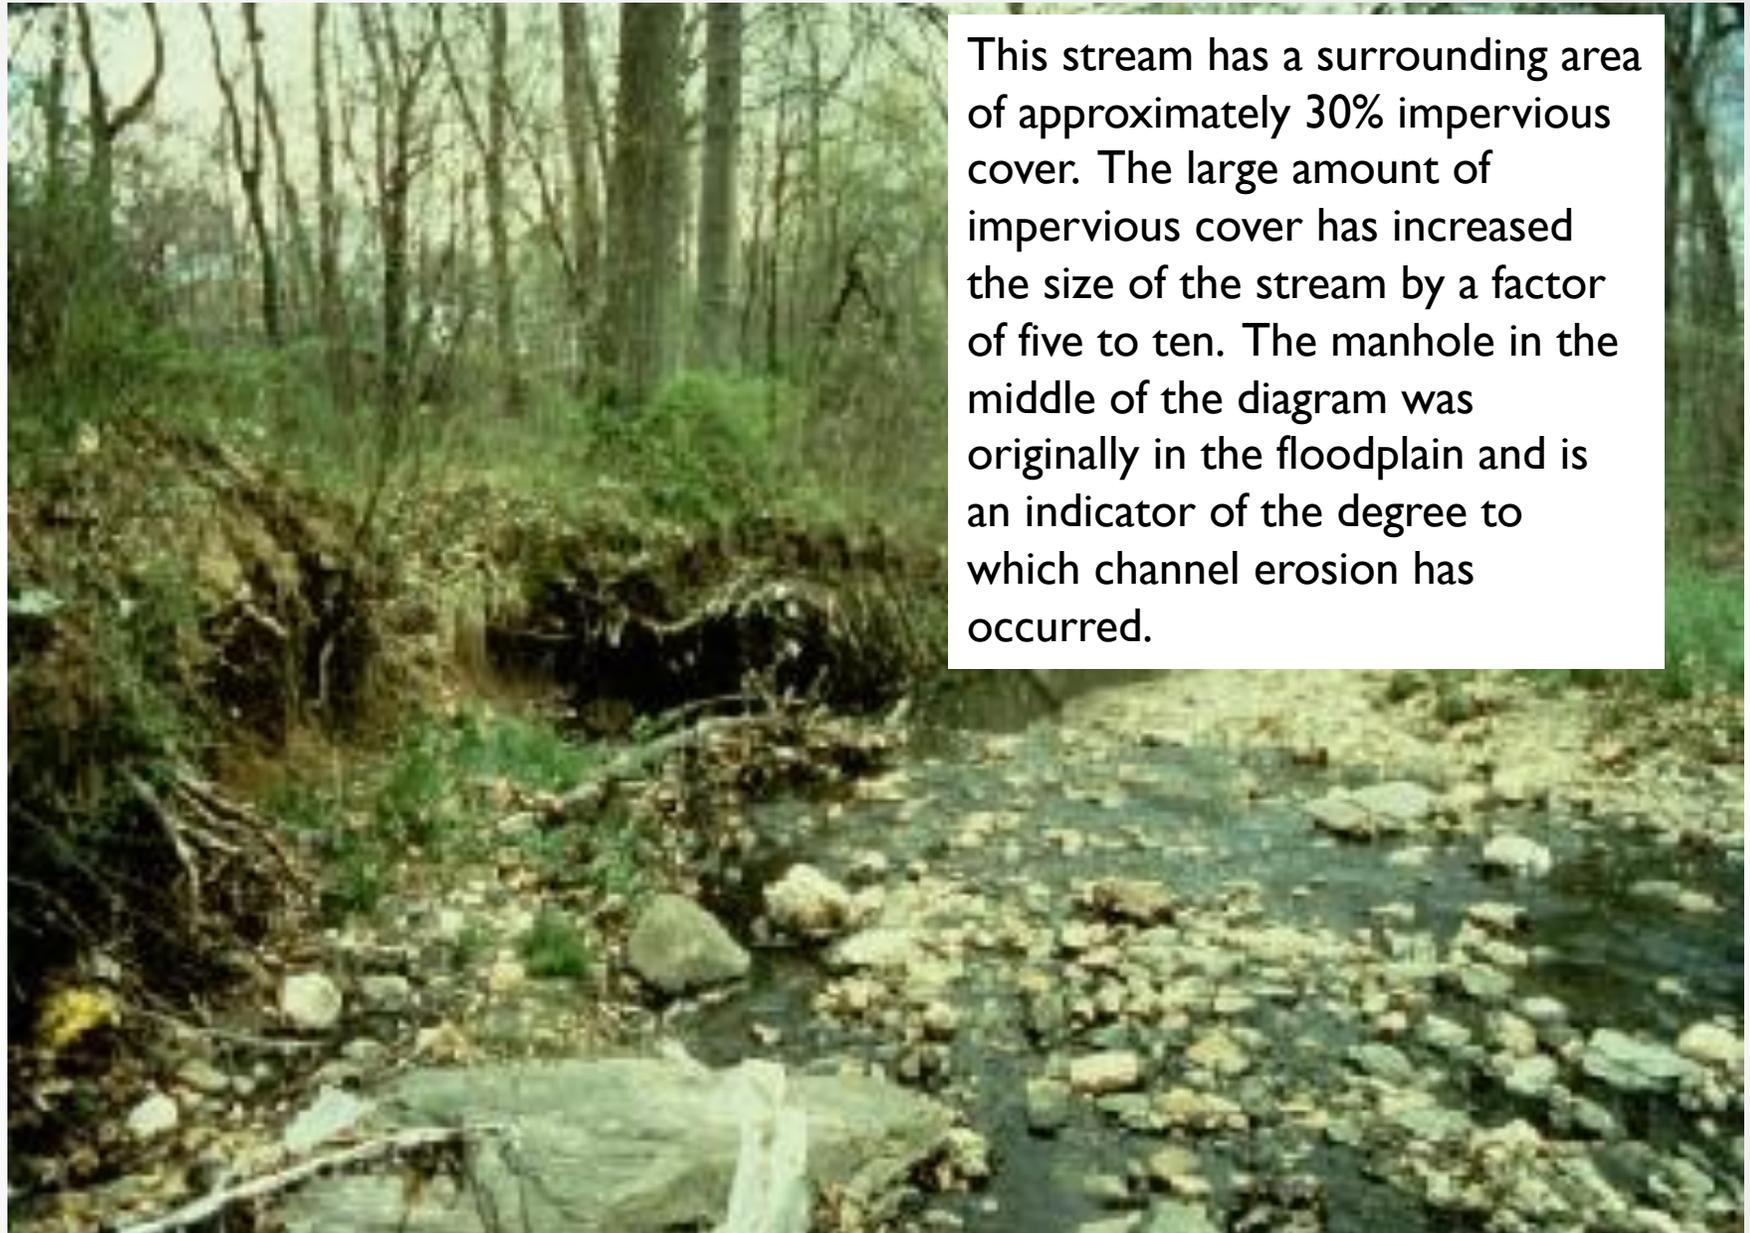
30% IC

This stream has a surrounding area of approximately 30% impervious cover. The large amount of impervious cover has increased the size of the stream by a factor of five to ten. The manhole in the middle of the diagram was originally in the floodplain and is an indicator of the degree to which channel erosion has occurred.

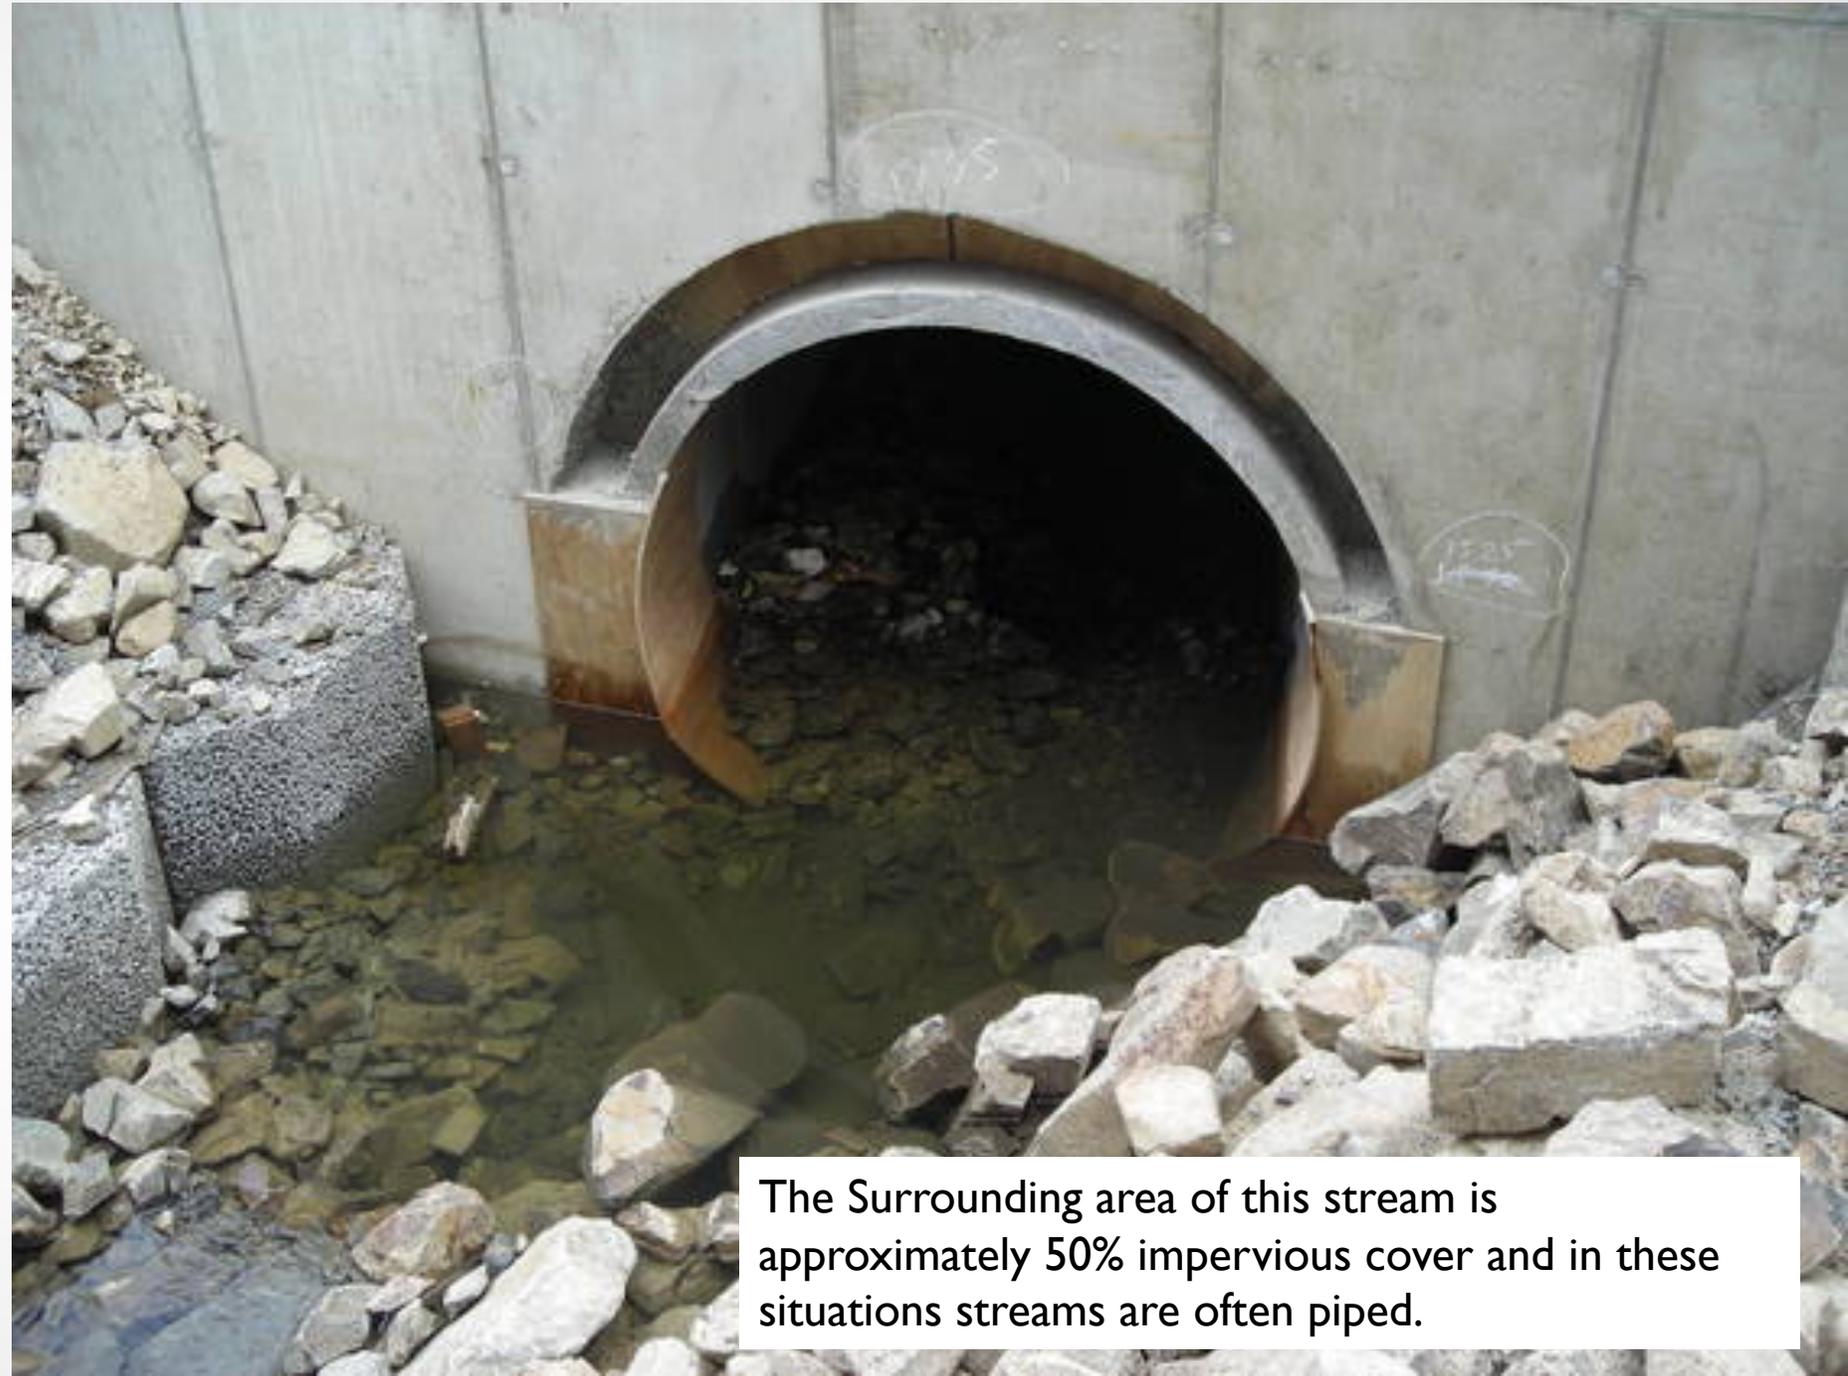
The Surrounding area of this stream is approximately 50% impervious cover and in these situations streams are often piped.

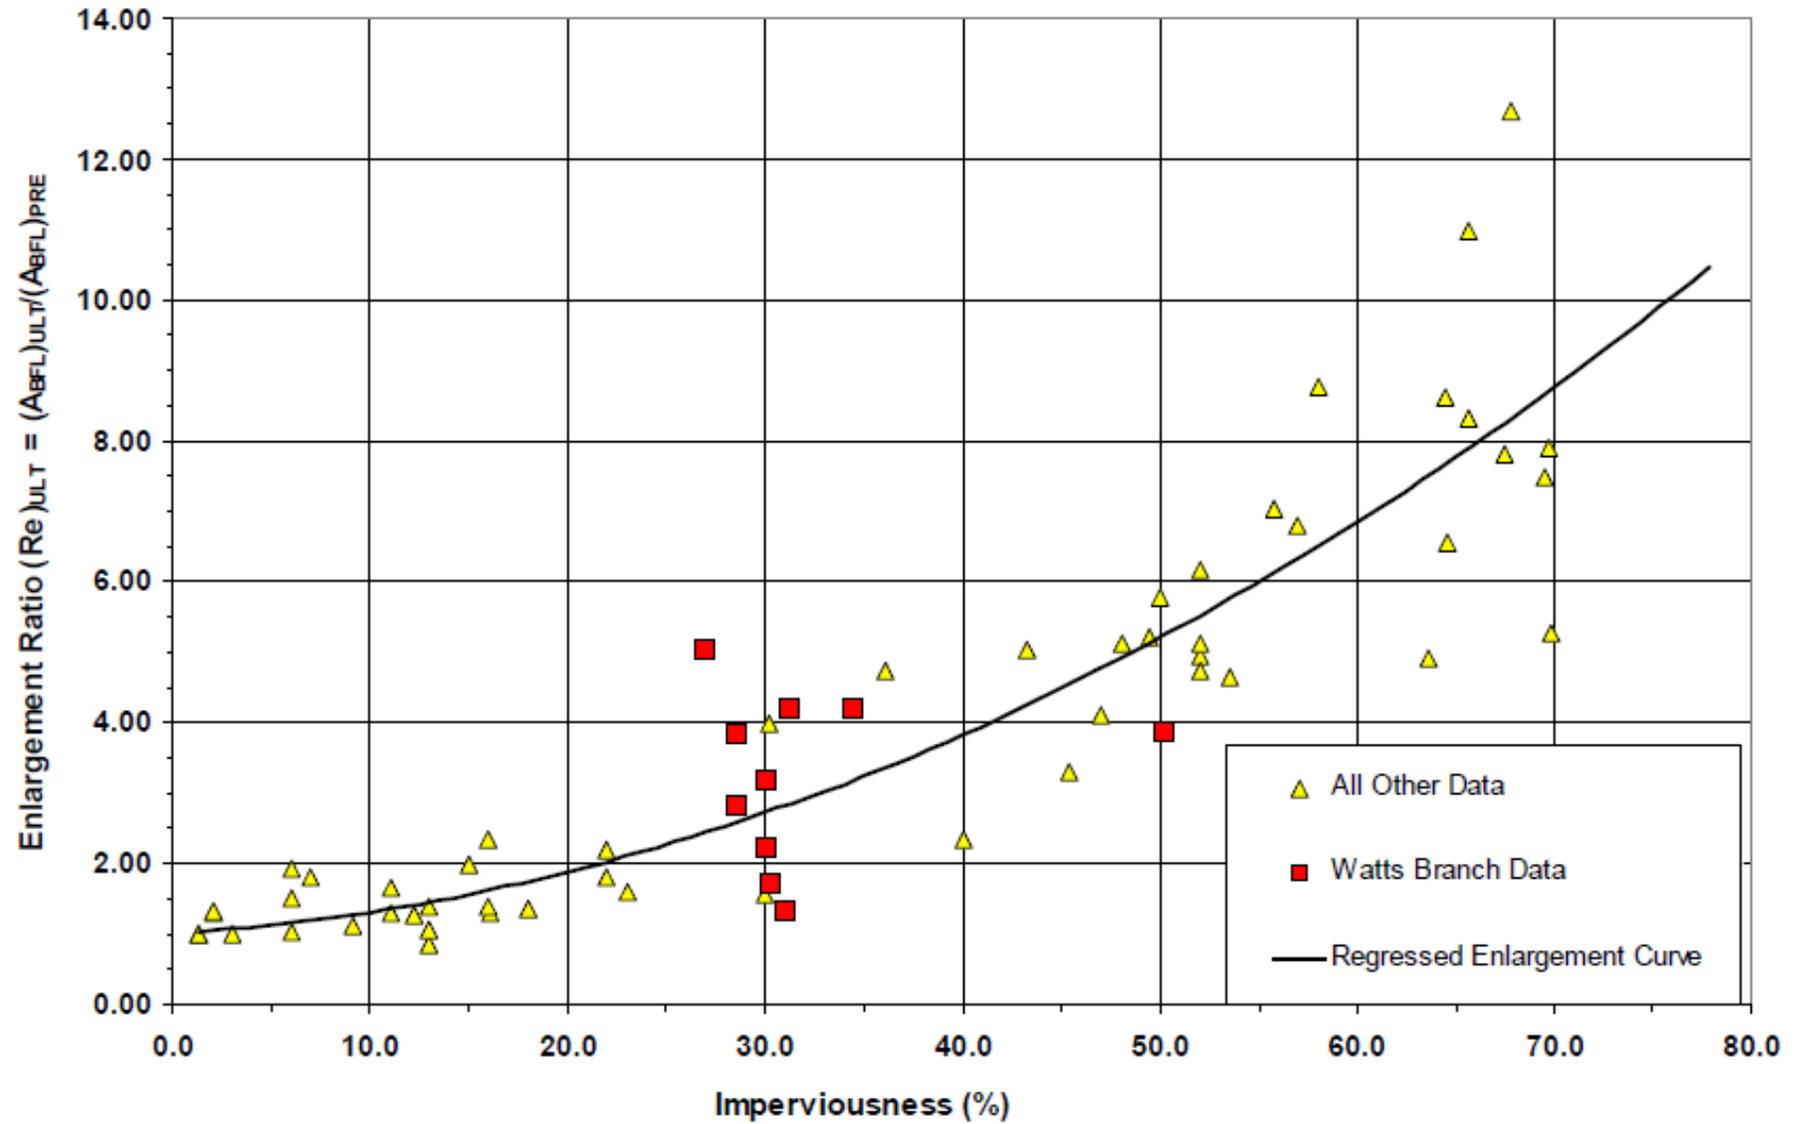
Enlargement Ratio as a Function of Impervious Cover

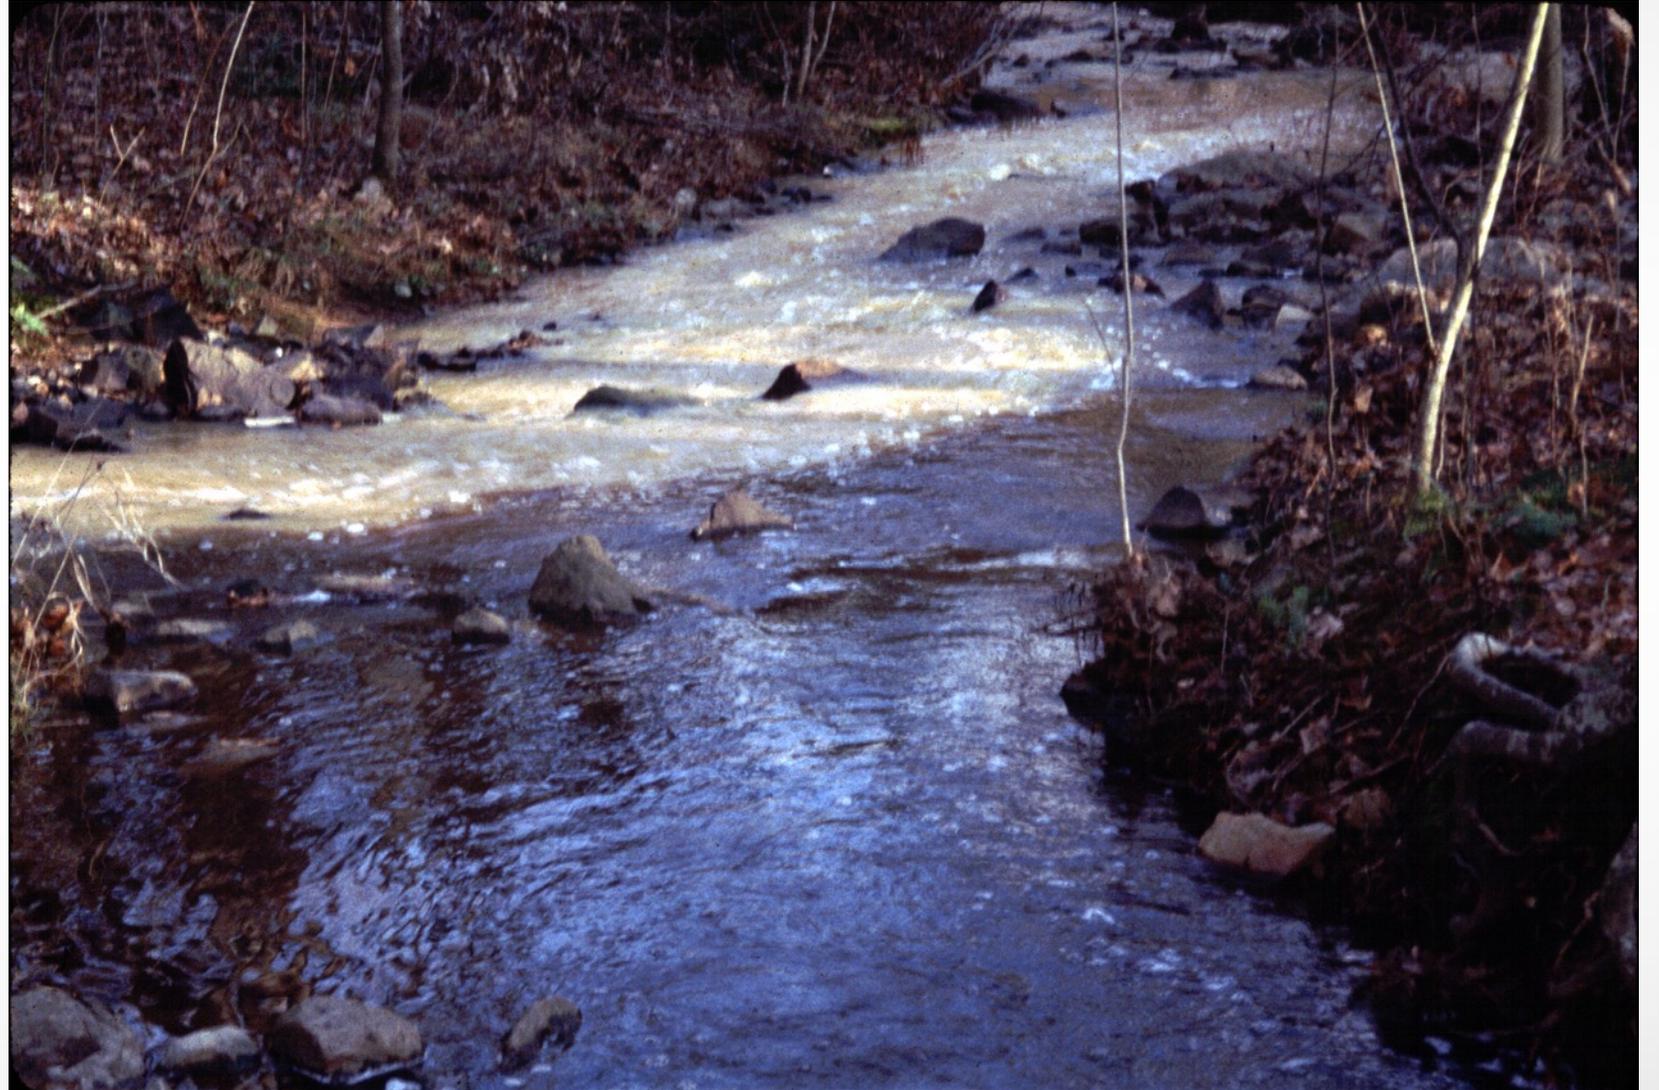
Convergence of Booker Creek (turbid) and Crow Branch Creek

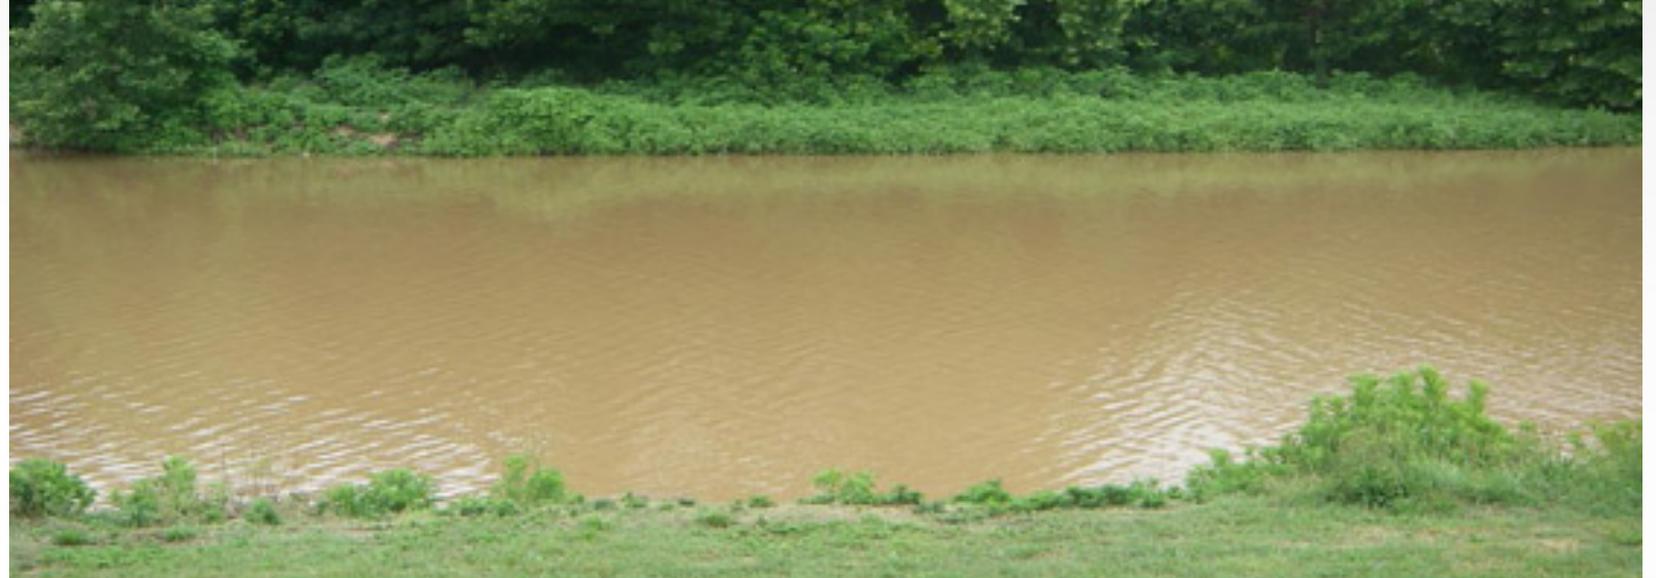
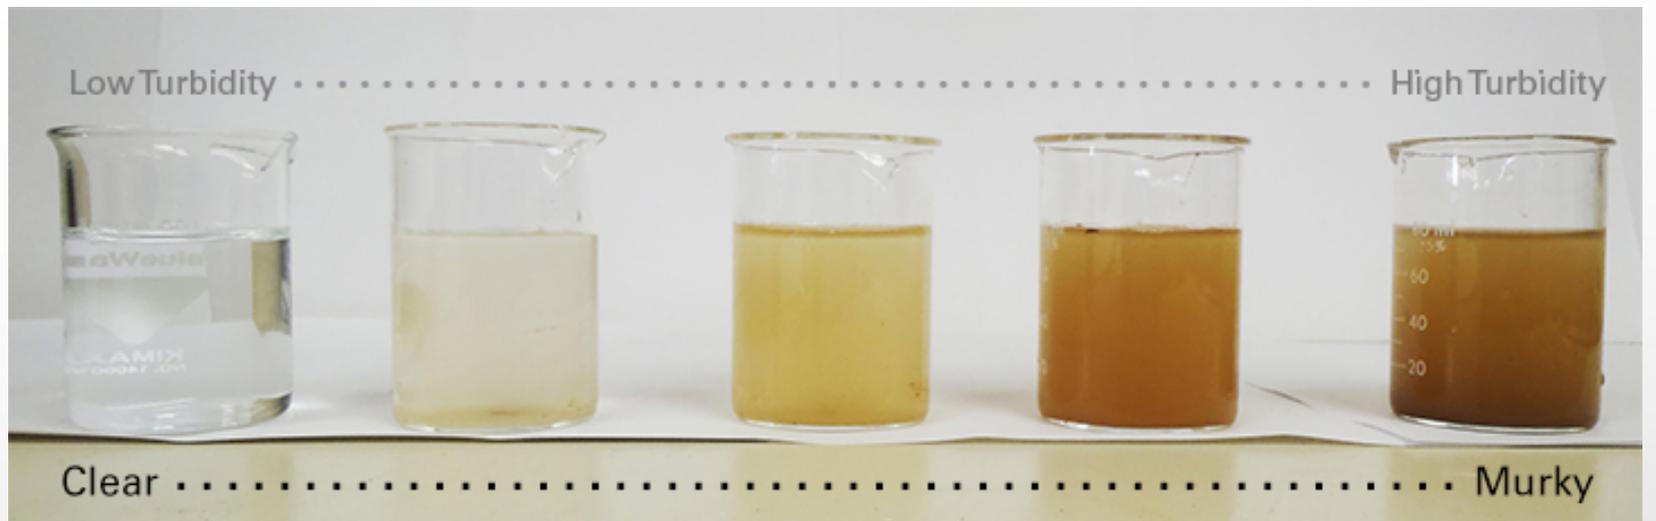
Turbidity even with treatment by temporary erosion control detention pond

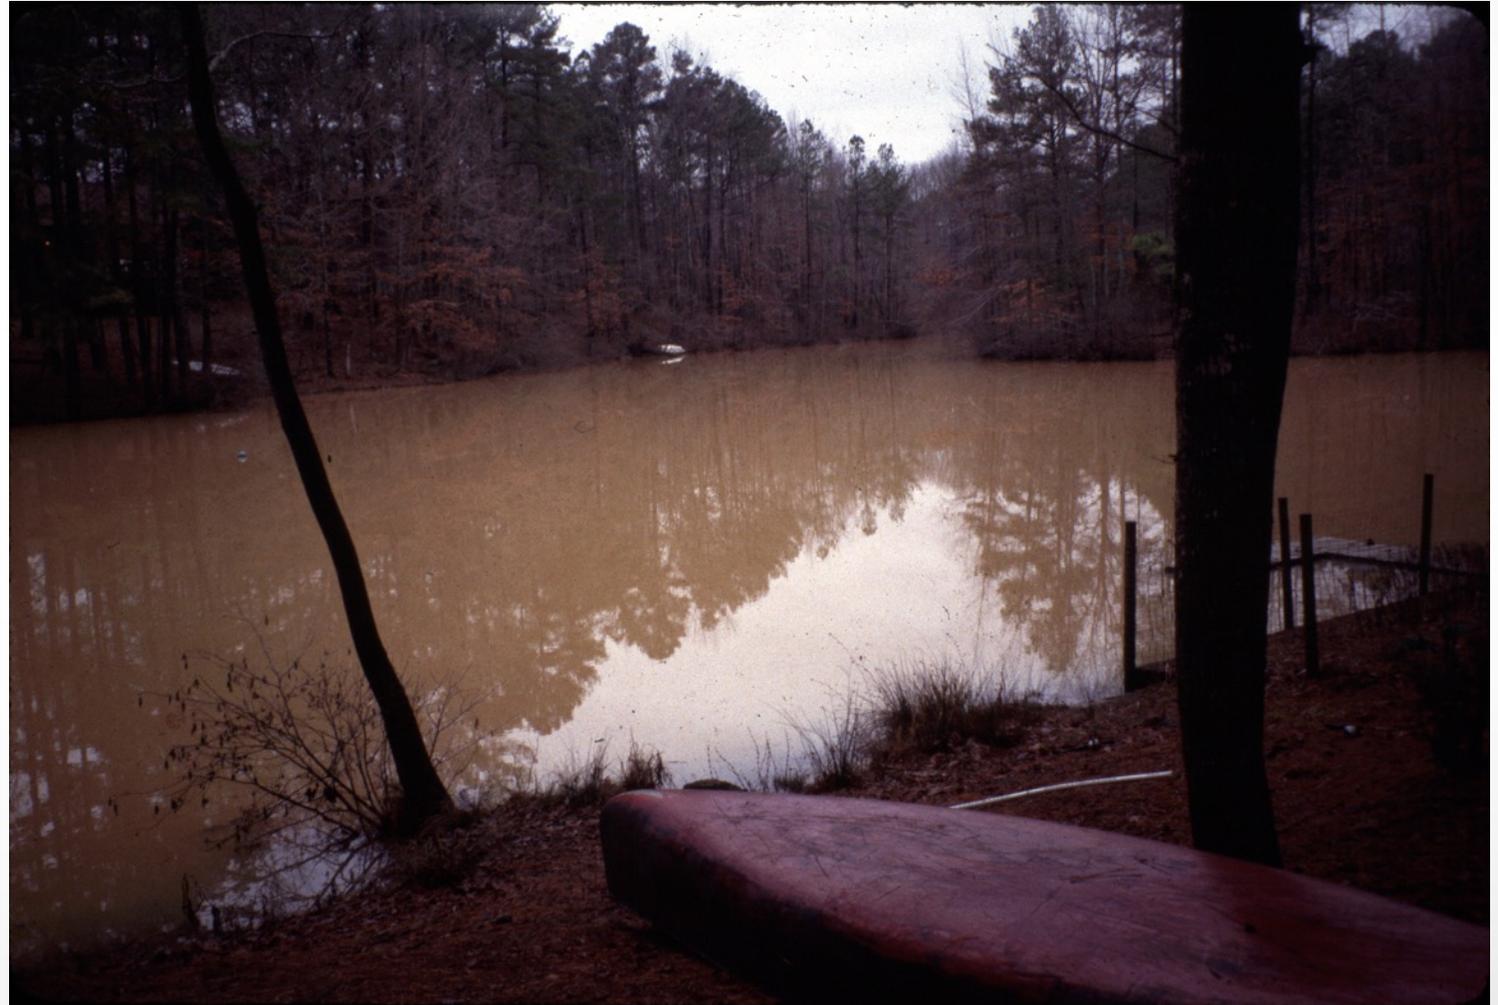
Lake Ellen: Downstream Effects of Construction Even With Erosion Control

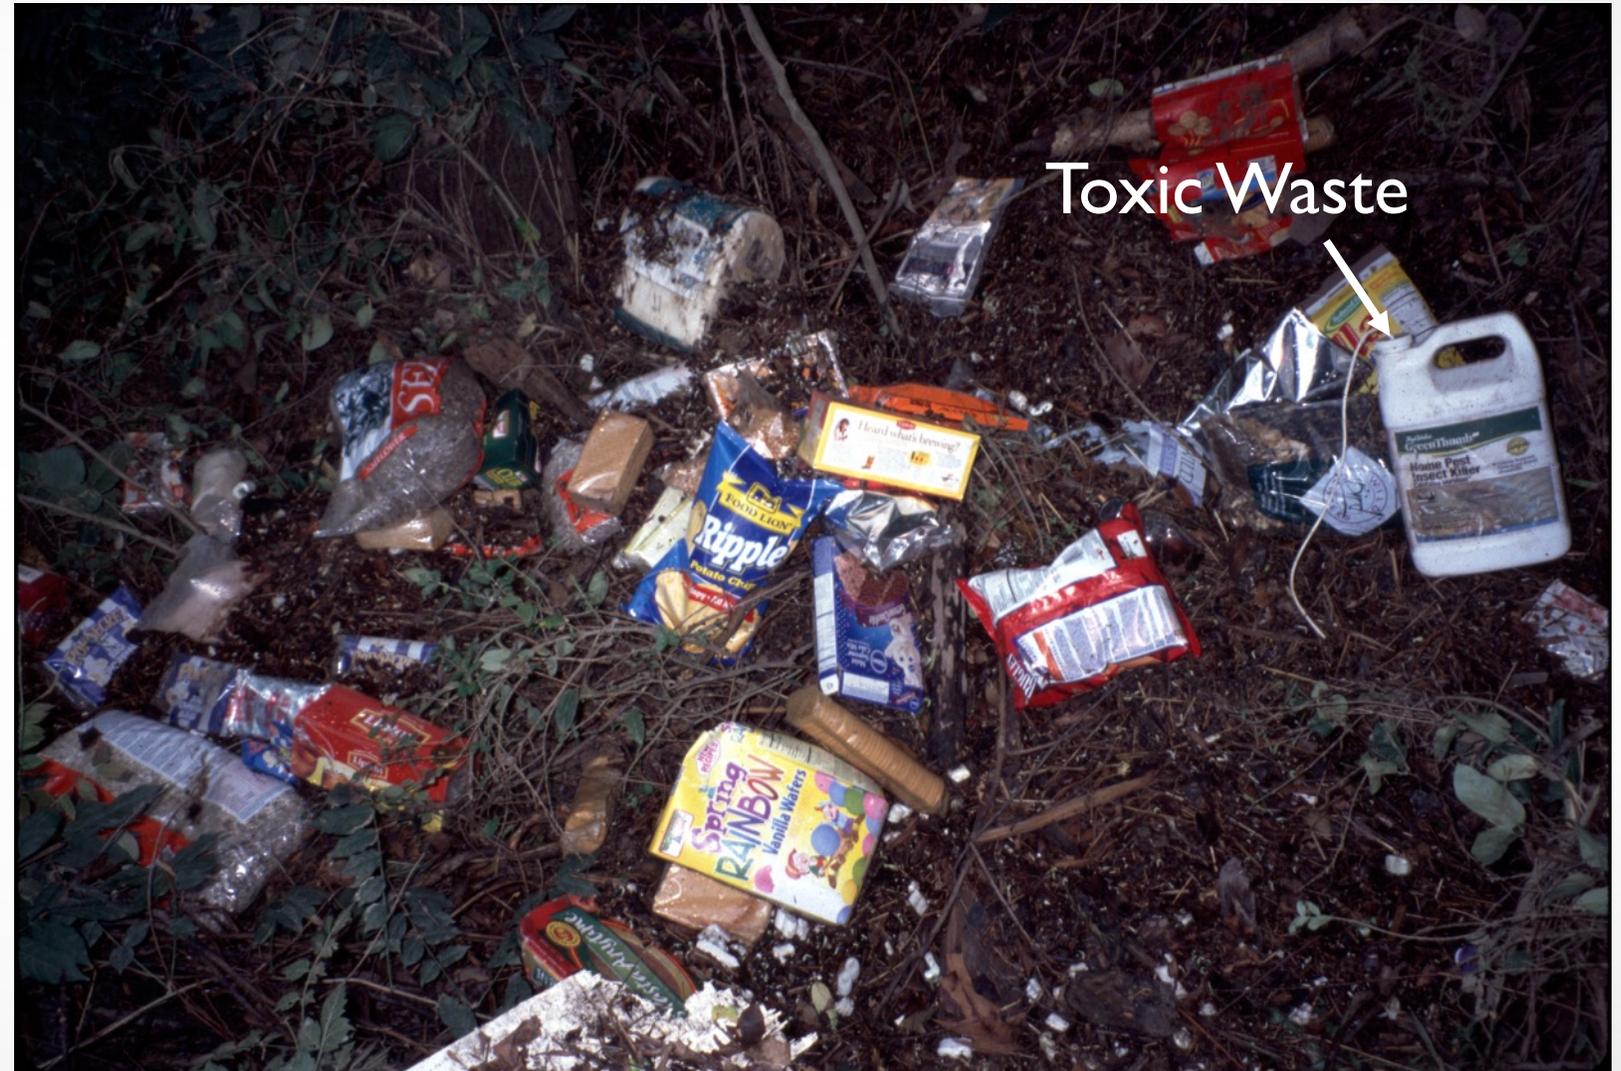
Debris Along Booker Creek Downstream of Eastgate Mall After Flood
