Todd BenDor
bendor@unc.edu

Sub-Watershed and Stream Evaluation

Thinking about Sub-watersheds

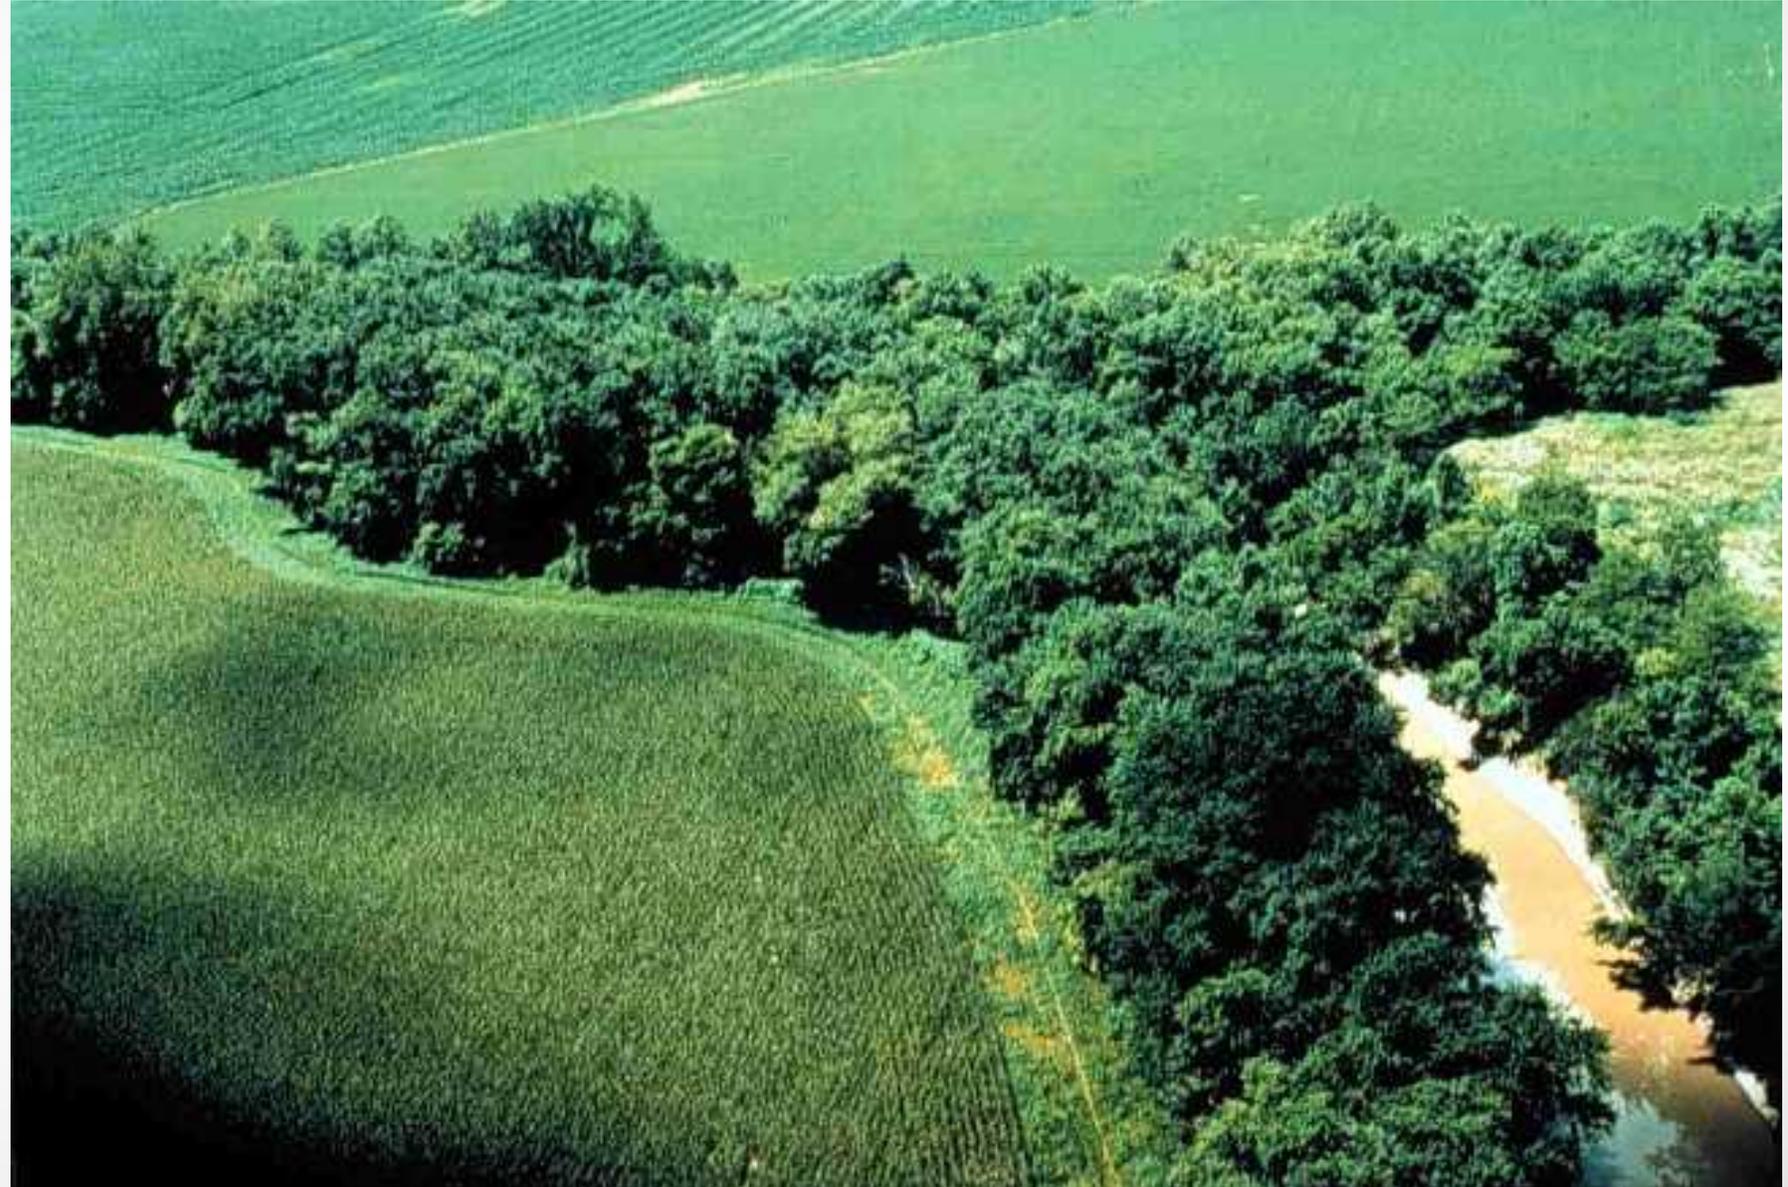
Is this buffer high quality? Consider Width and Canopy

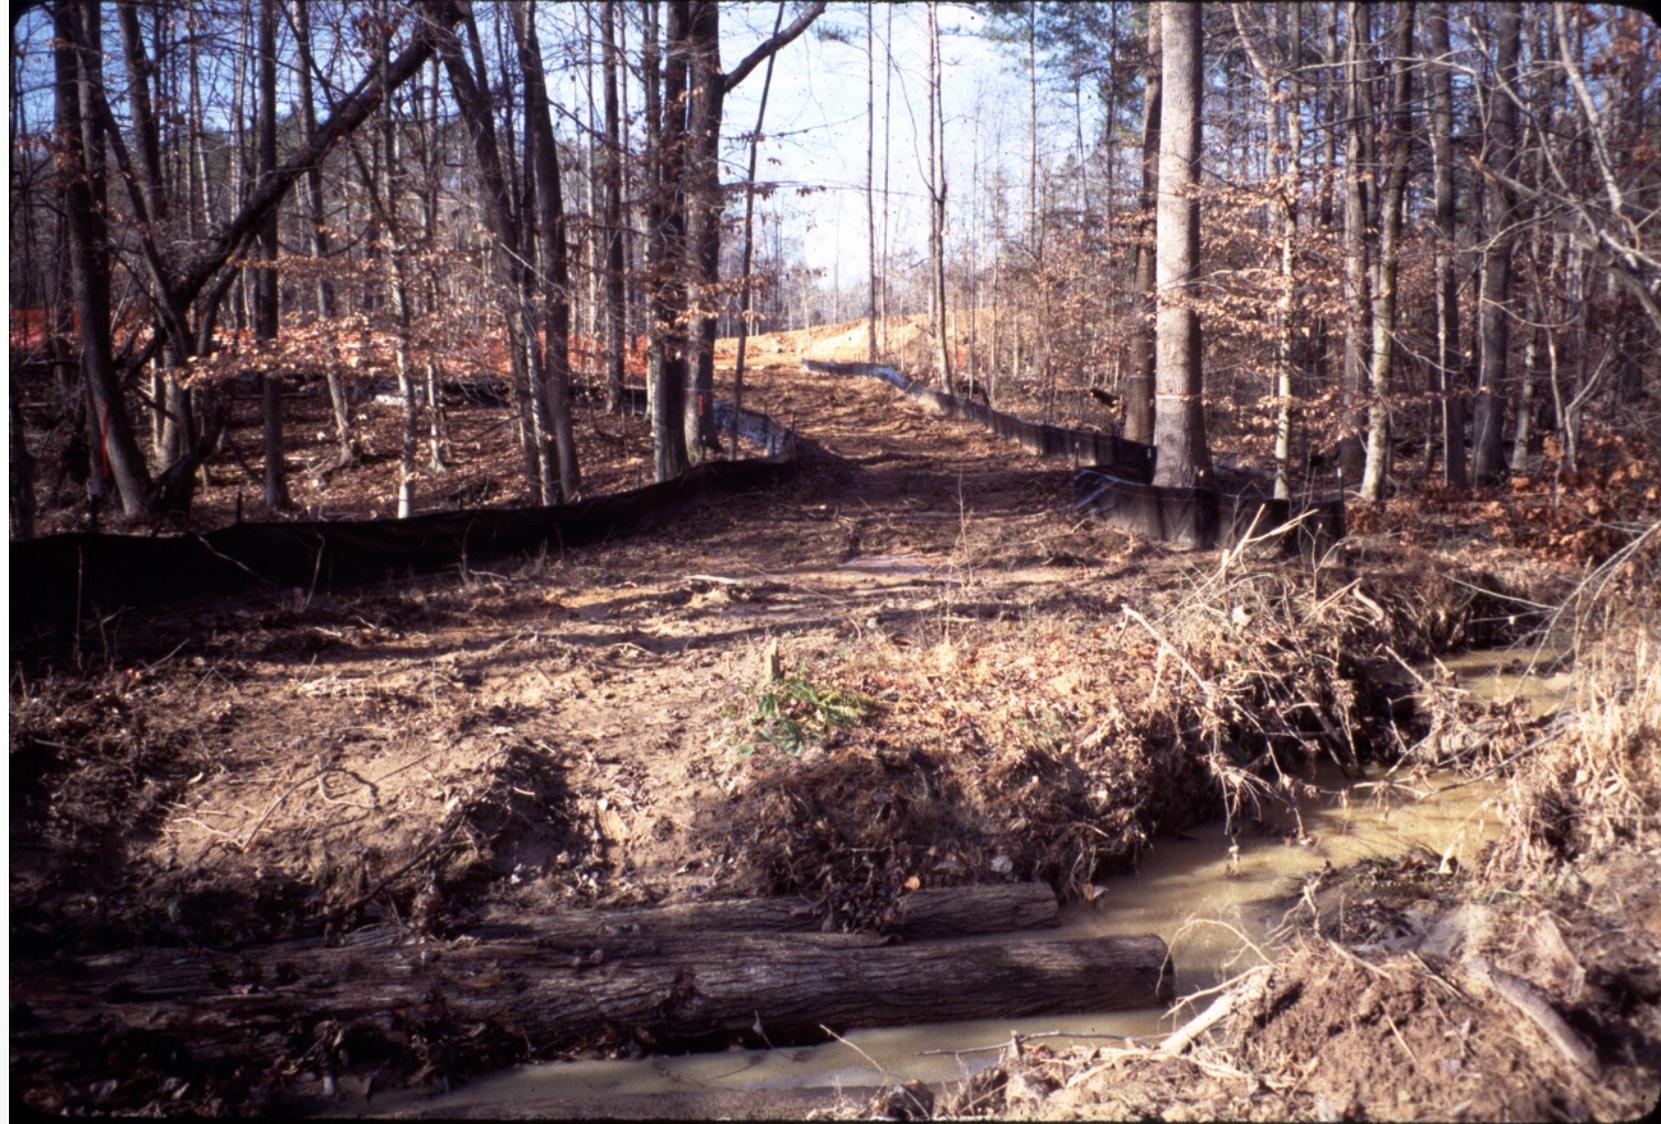
Intermittent Tributary to Booker Creek: Loss of Vegetation in Riparian Zone, Exposed Roots, Upward Gullying (note: erosion control fences)

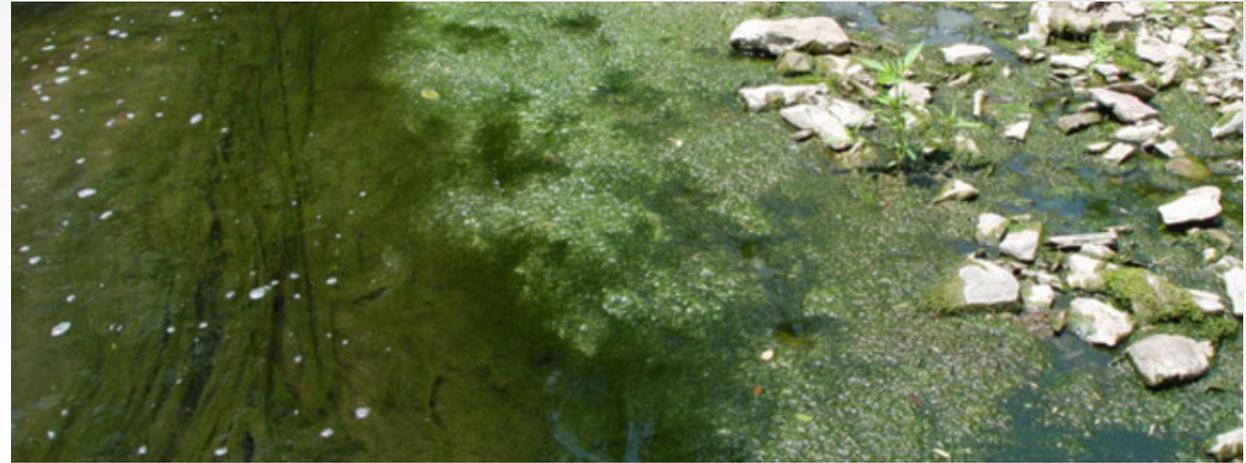
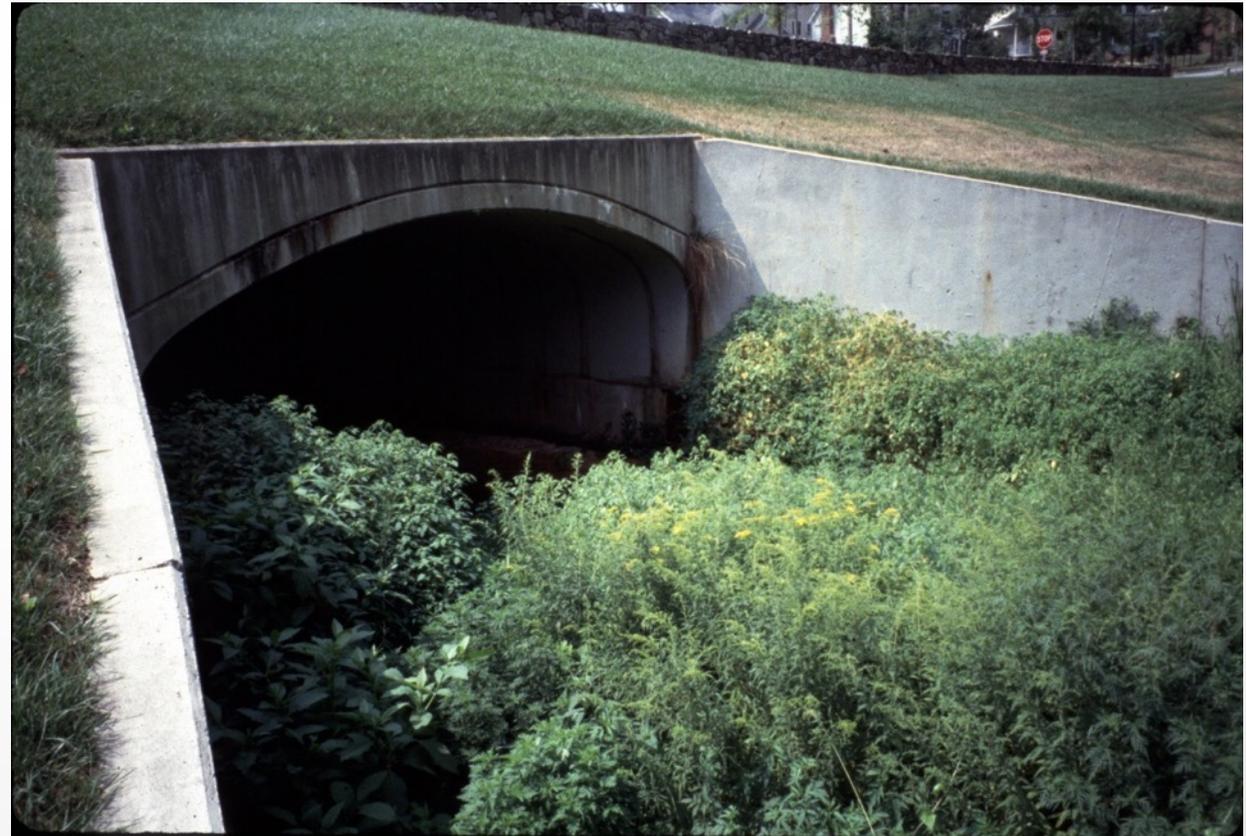
Channel Near Southern Village
Choked with Vegetation. Too
Much Sunlight and Sedimentation

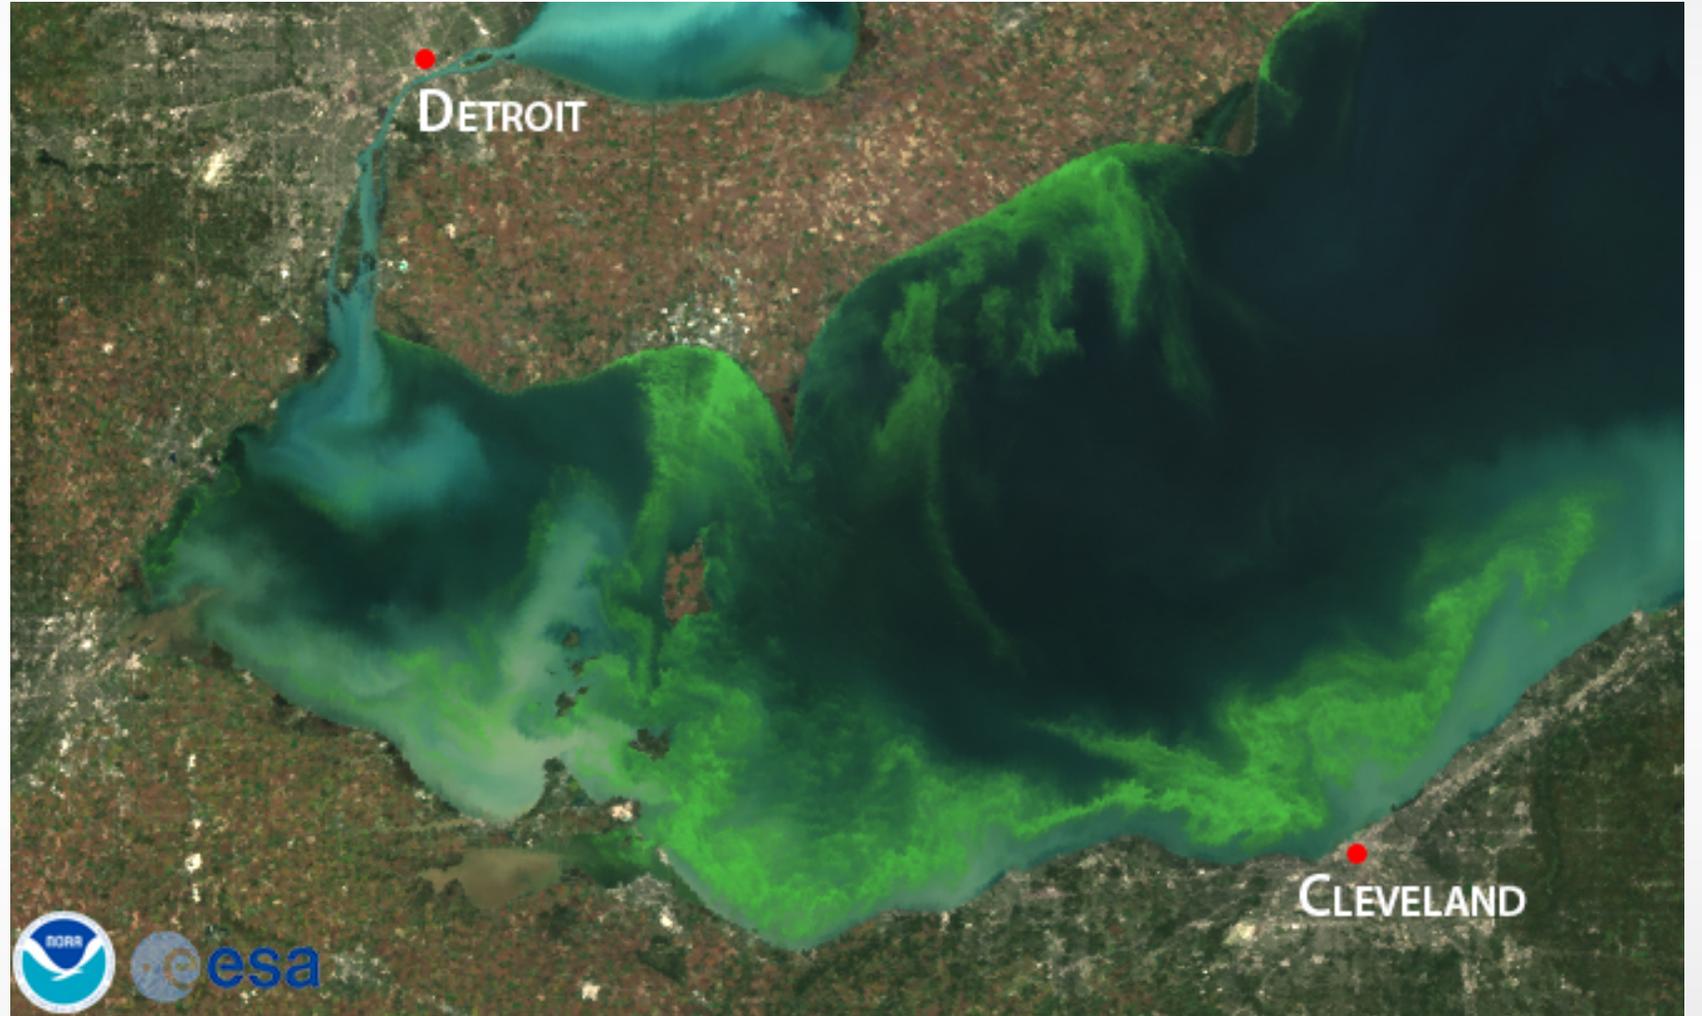
Nutrient enrichment: where it can eventually lead...

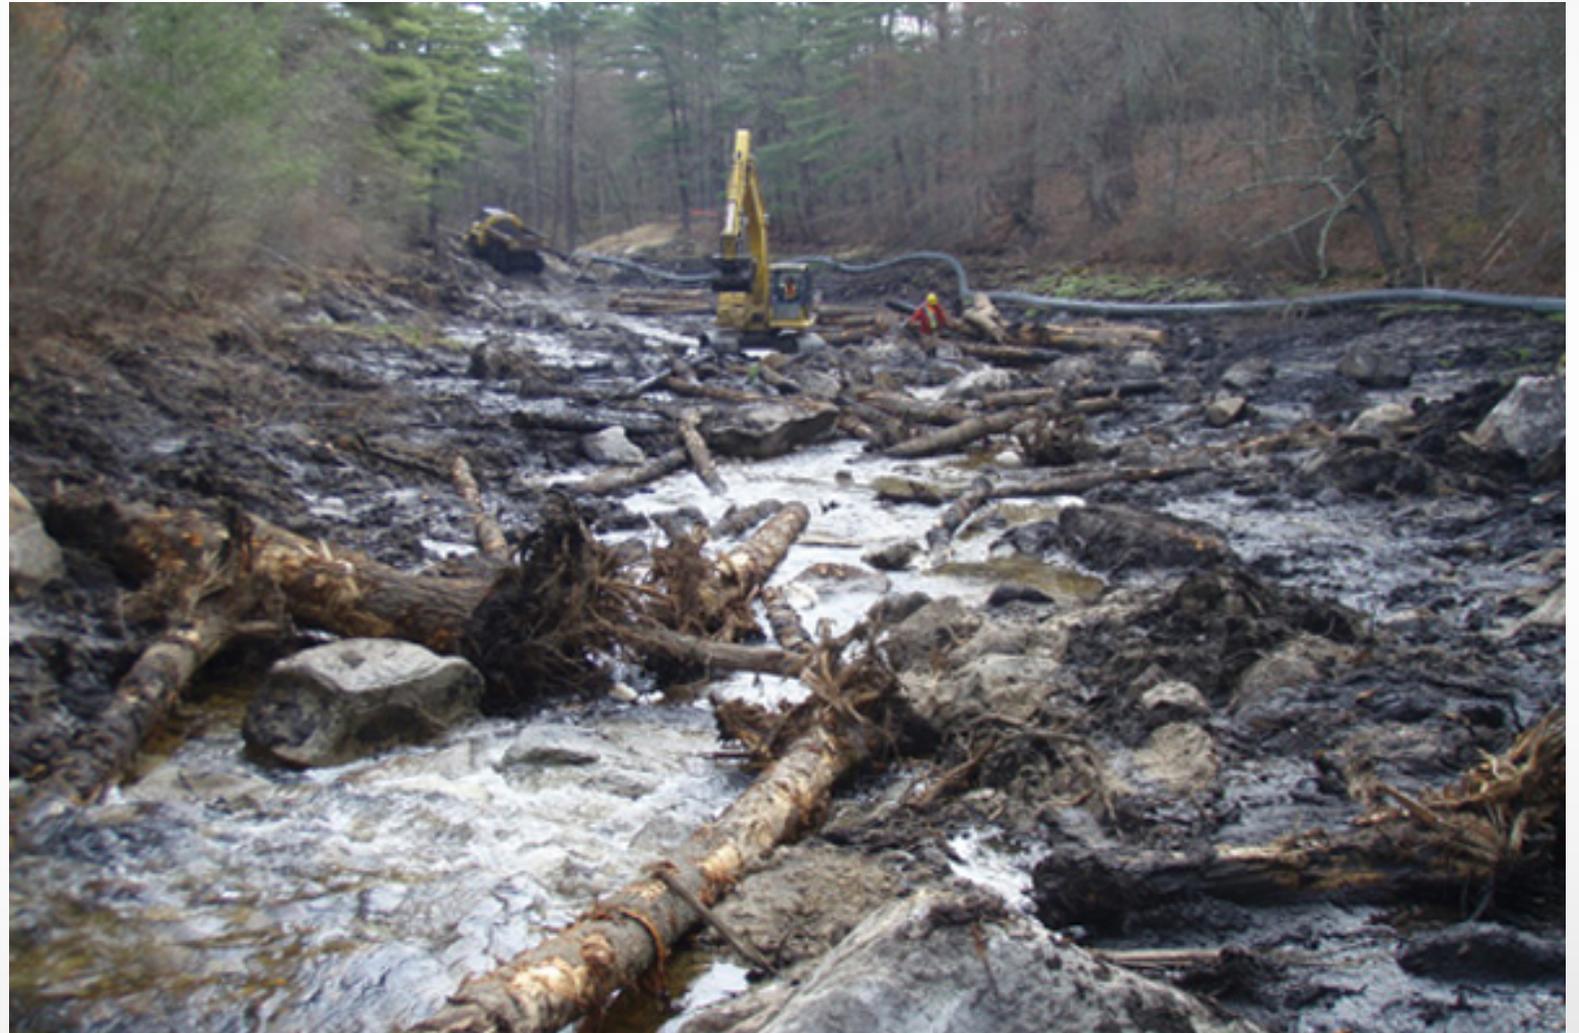
Properly positioned natural debris in channel: supports habitat and minimizes back flow

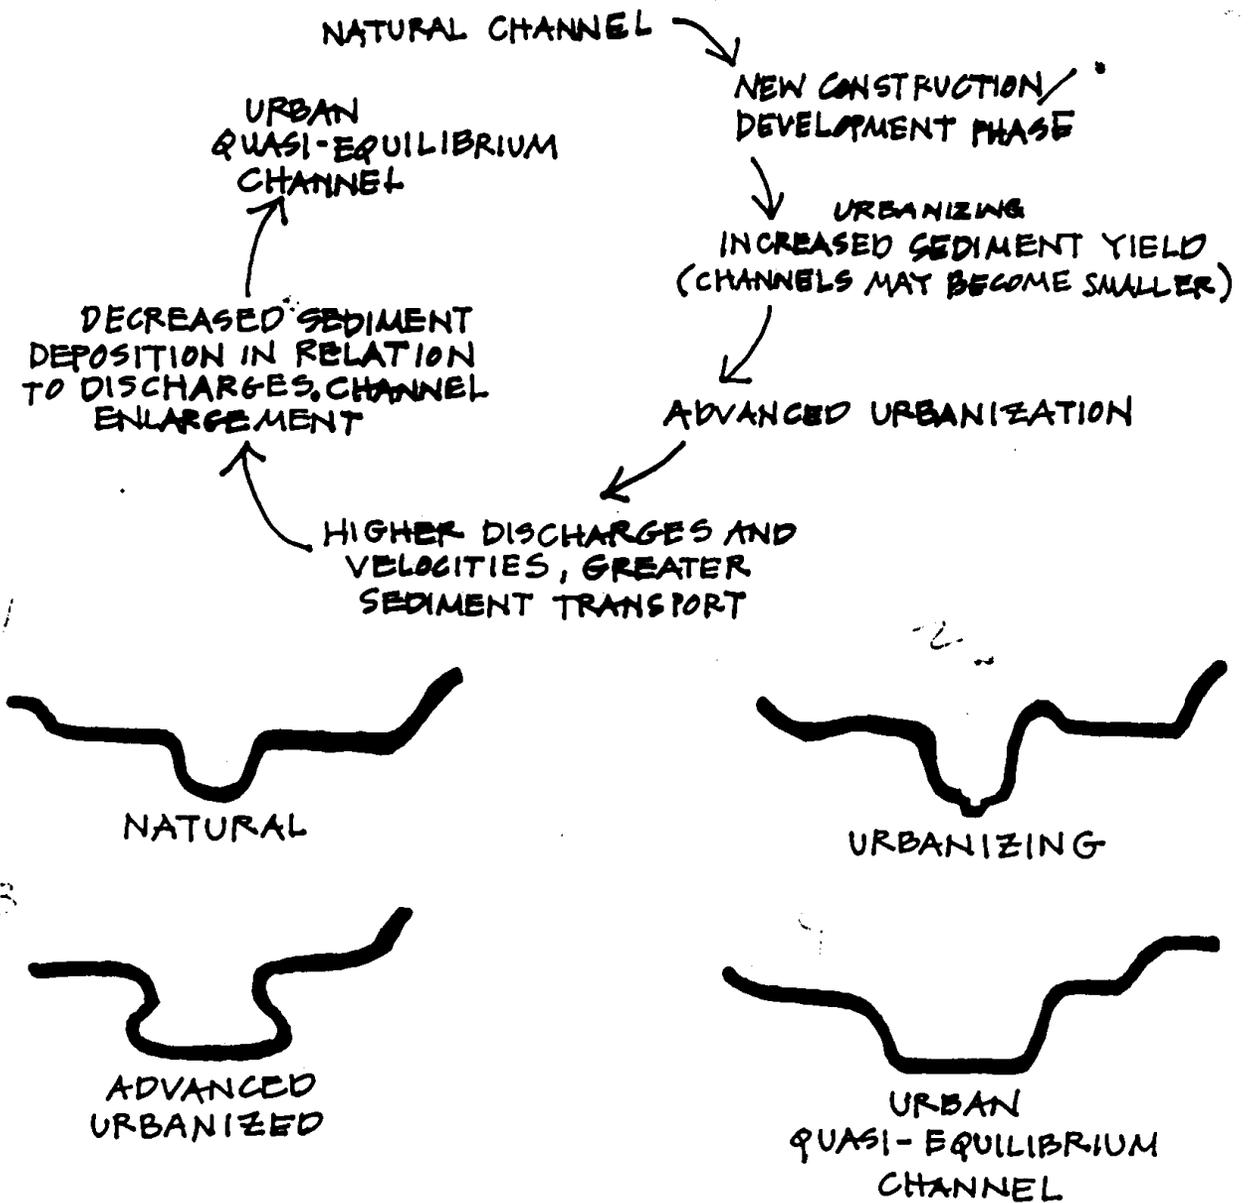
FIGURE 4.8. A TYPICAL CYCLE OF STREAM CHANNEL ADJUSTMENTS TO URBANIZATION.

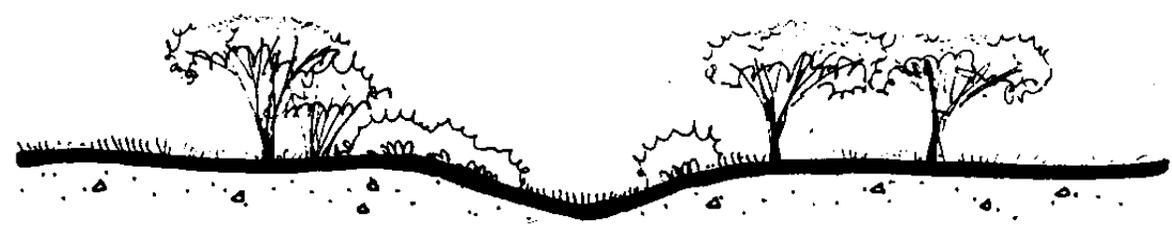
Successive stages in gully formation from runoff increases

Trough of valley in natural state. Protected by grass and vegetation.

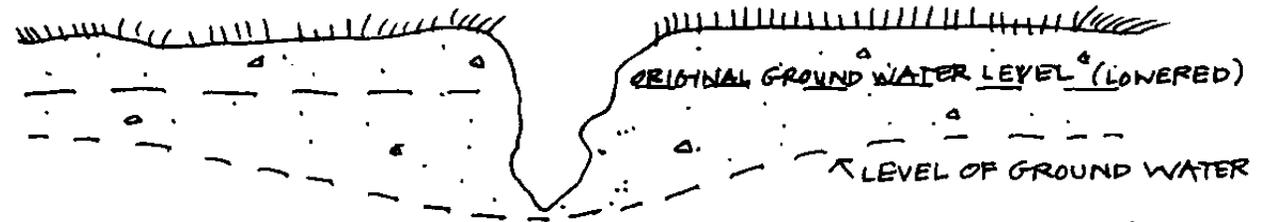
Gully formed in trough of valley by increase in rate of runoff associated with the decline of vegetative cover.

Second-stage gully, causing greater depletion of vegetative cover in valley because of the lowering of the water table.

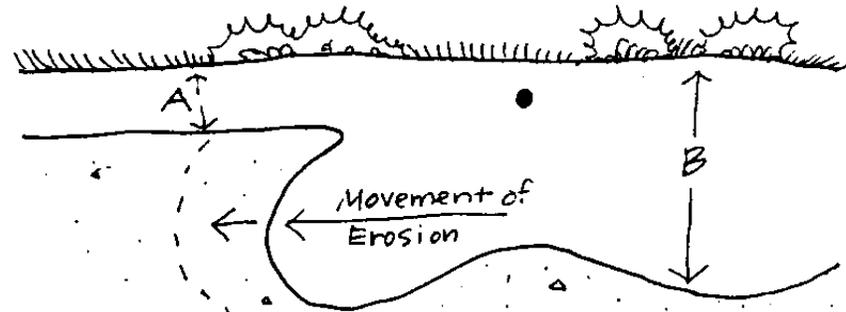
Gully depth "A" increases to depth "B" as the gully erosion moves up slope.

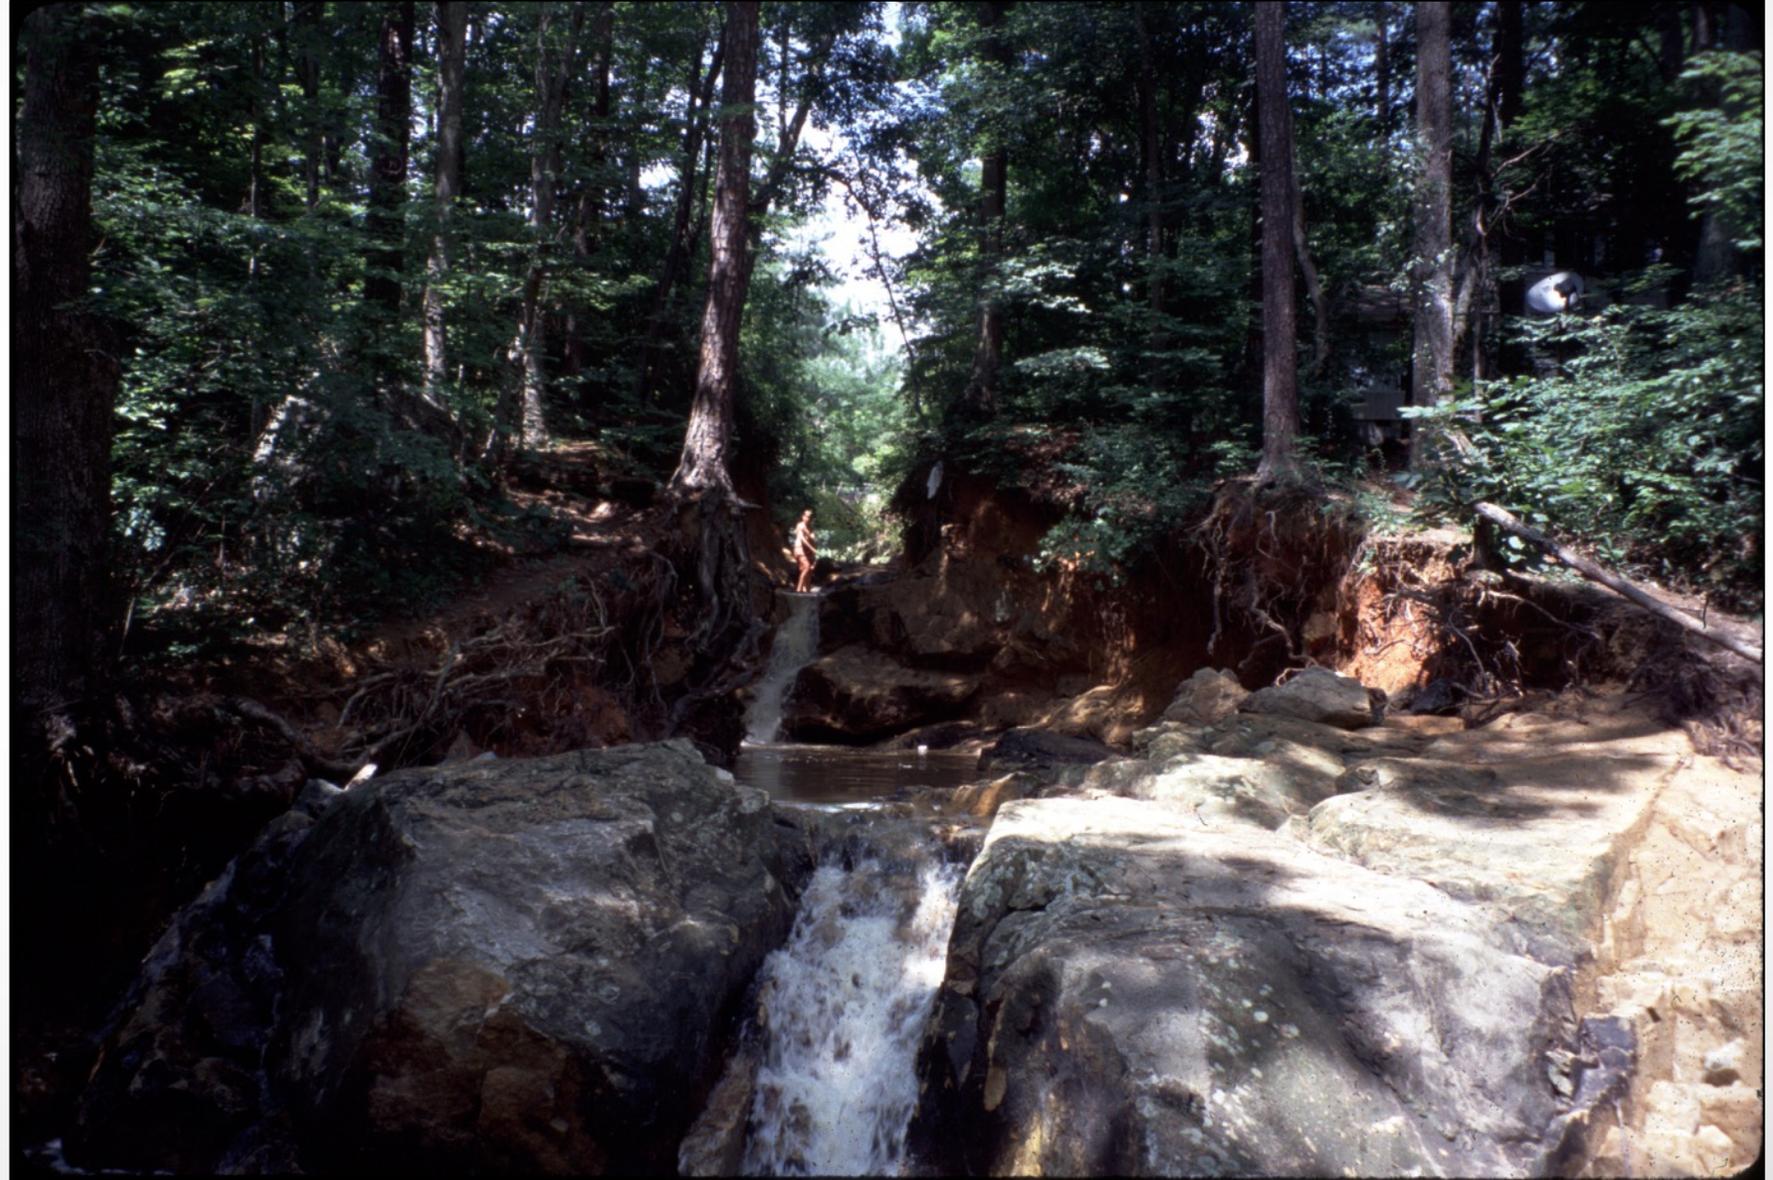
Advanced state of erosion in cycle of stream bank adjustment: grand canyon downstream of Lake Ellen dam

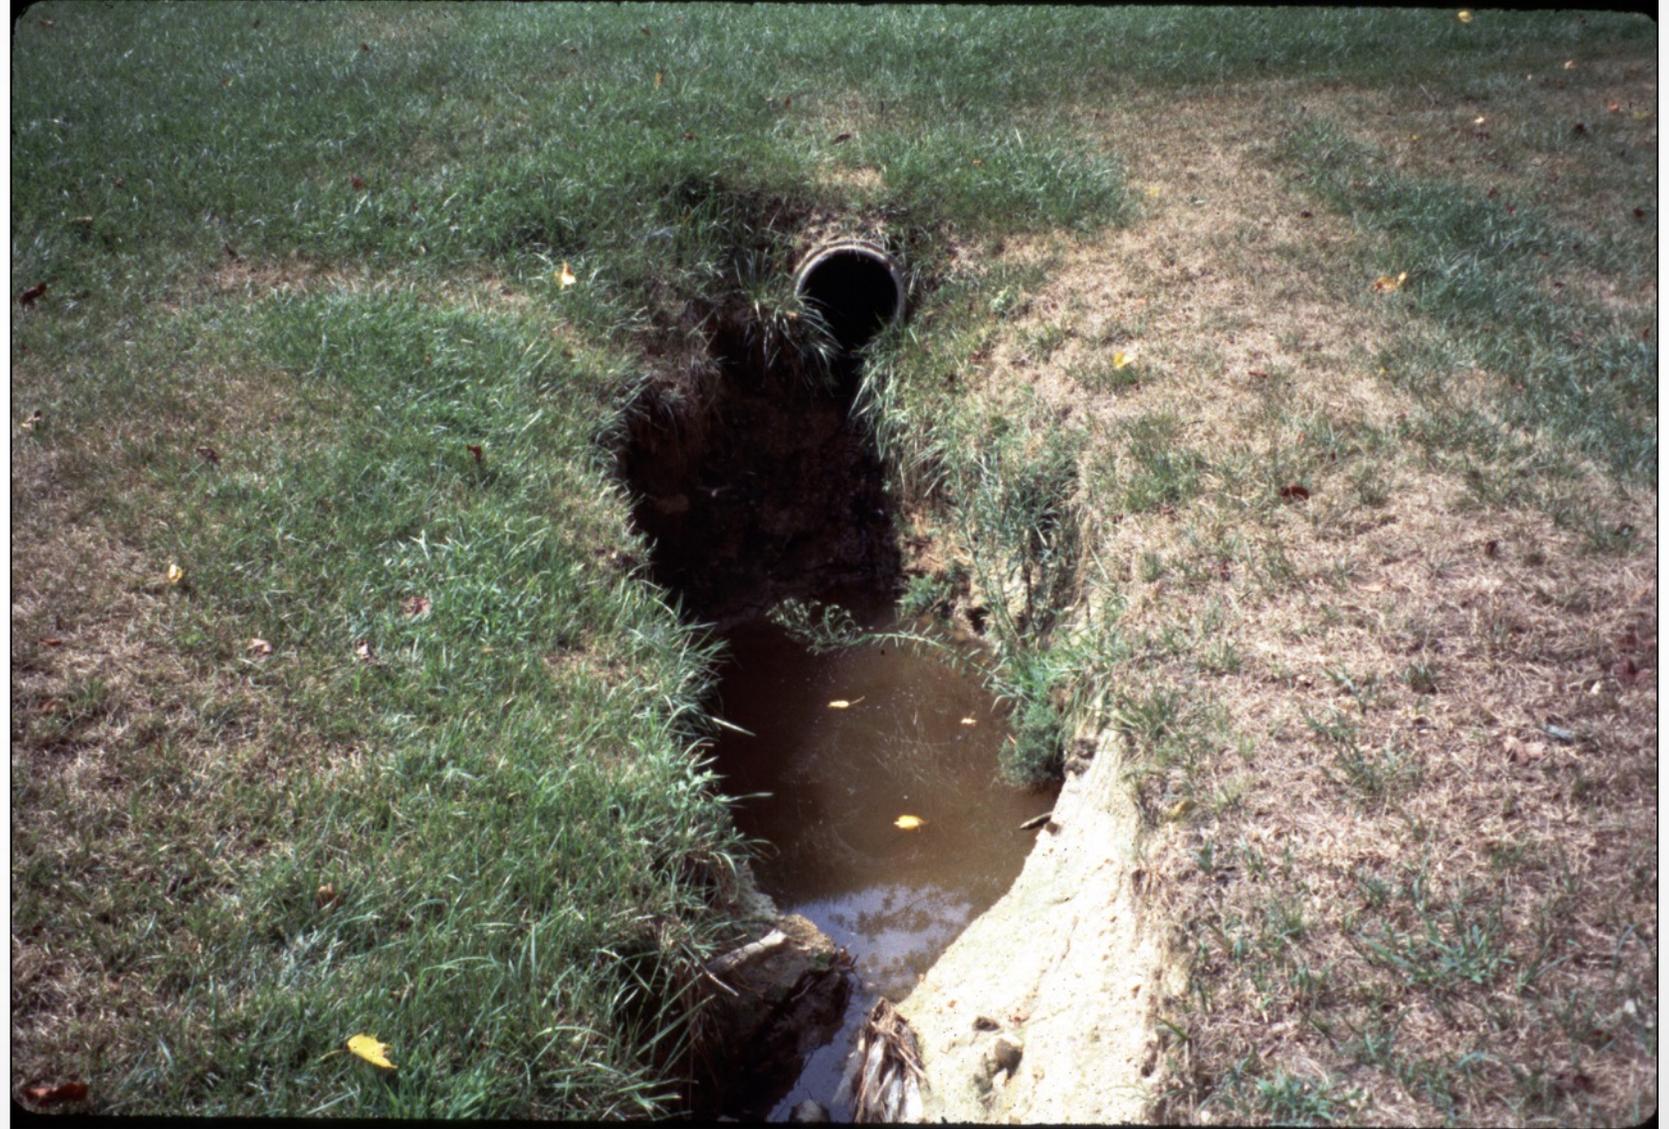
Early state of erosion cycle: Effects of stormwater pipe outfall from new road in southern village

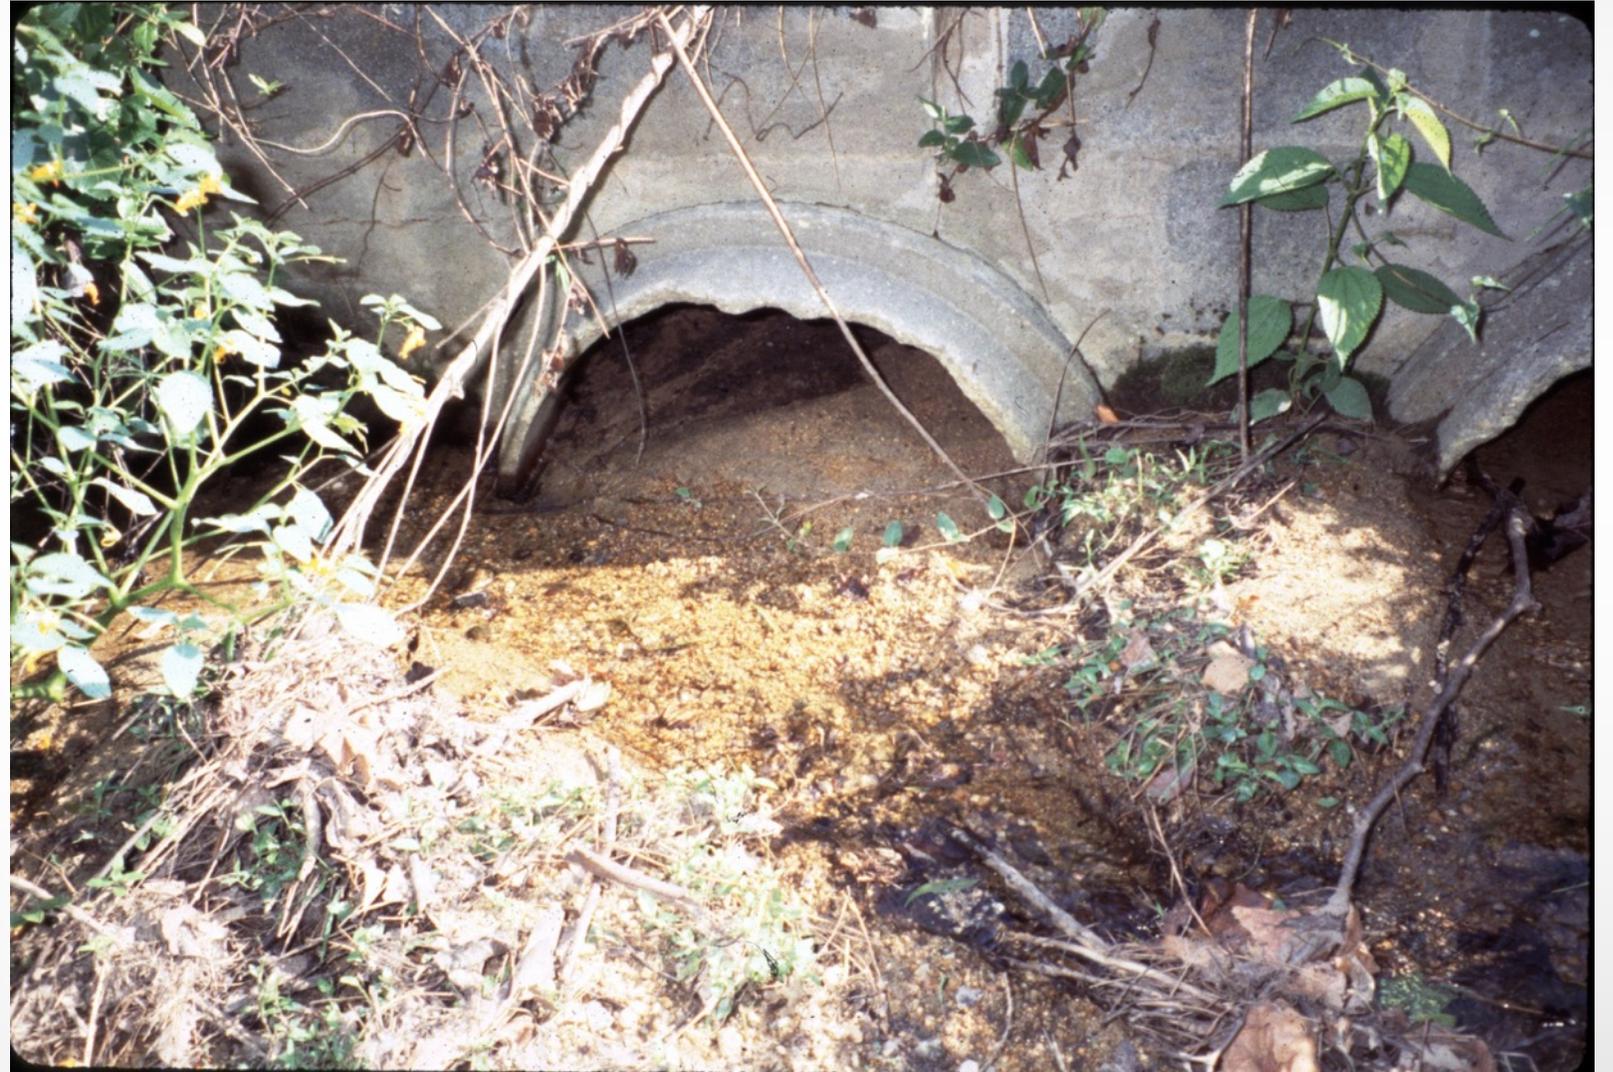
Stormwater pipe outfall under shoreline drive: signs of stream bank instability

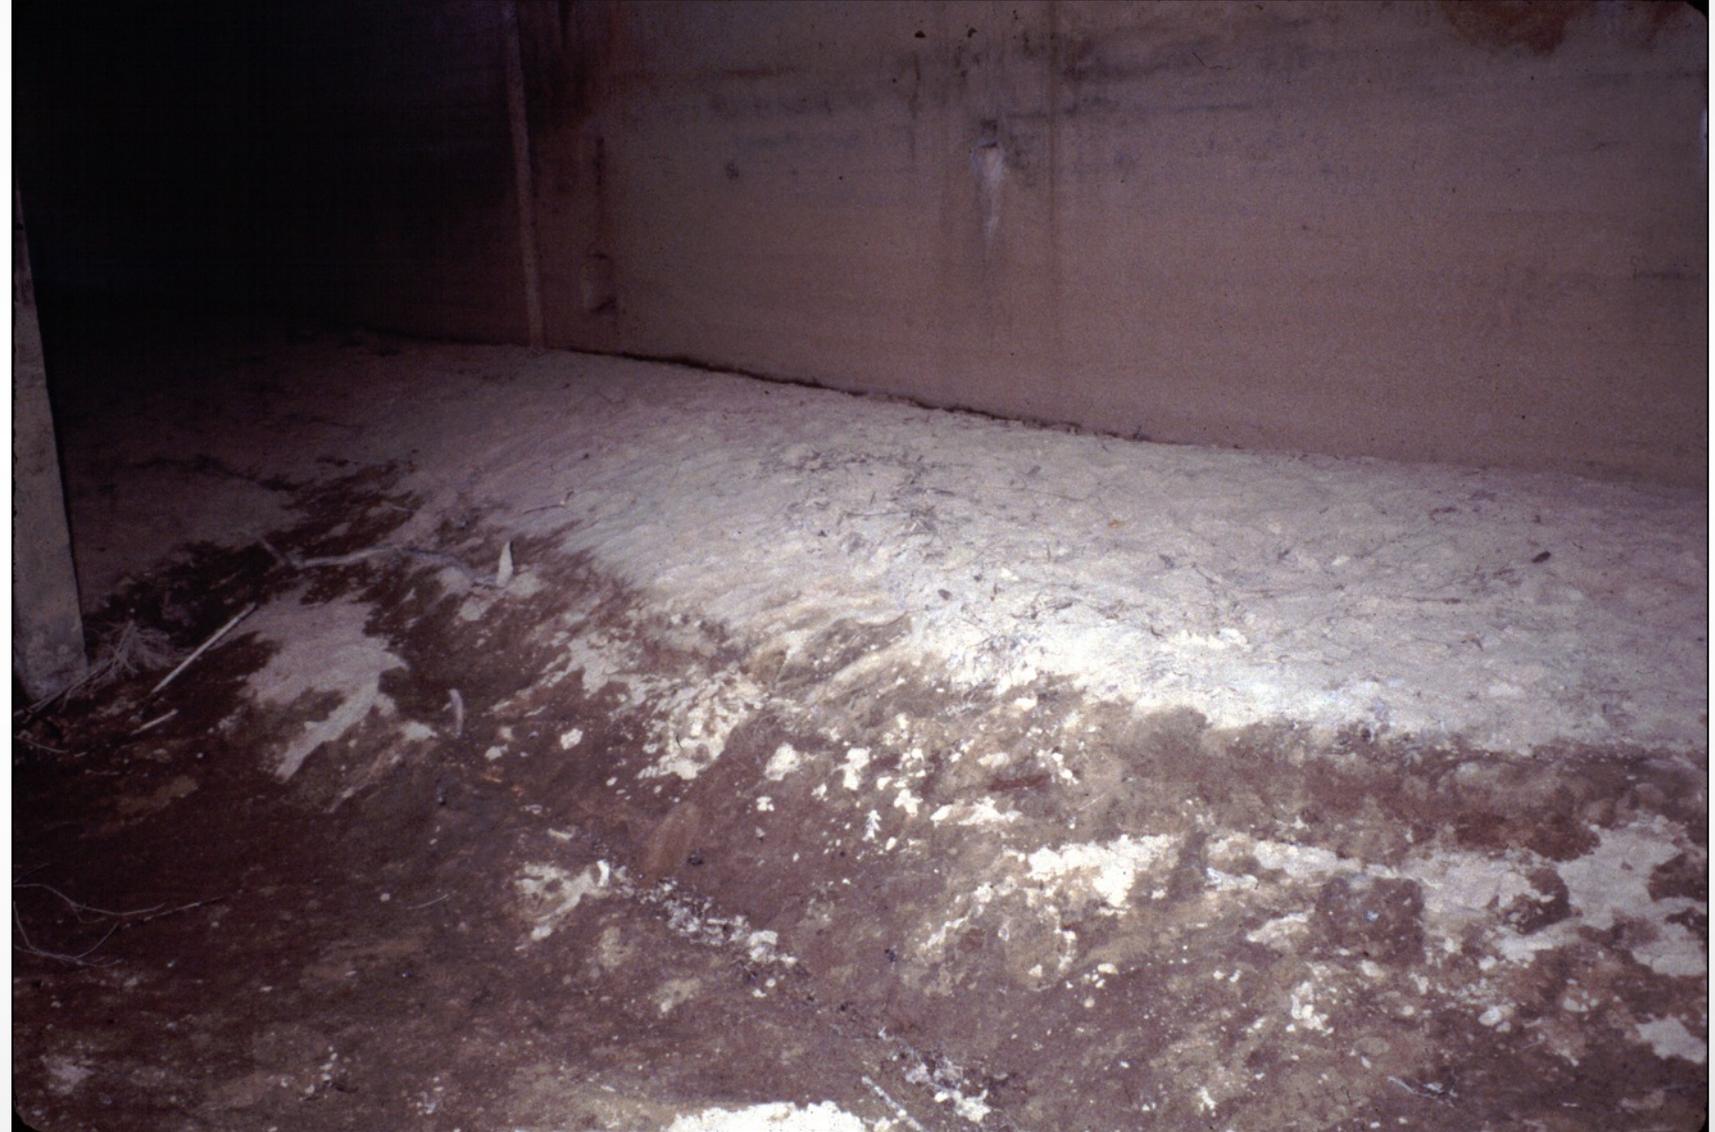
Sediment buildup in culvert under Franklin street near Eastgate shopping center

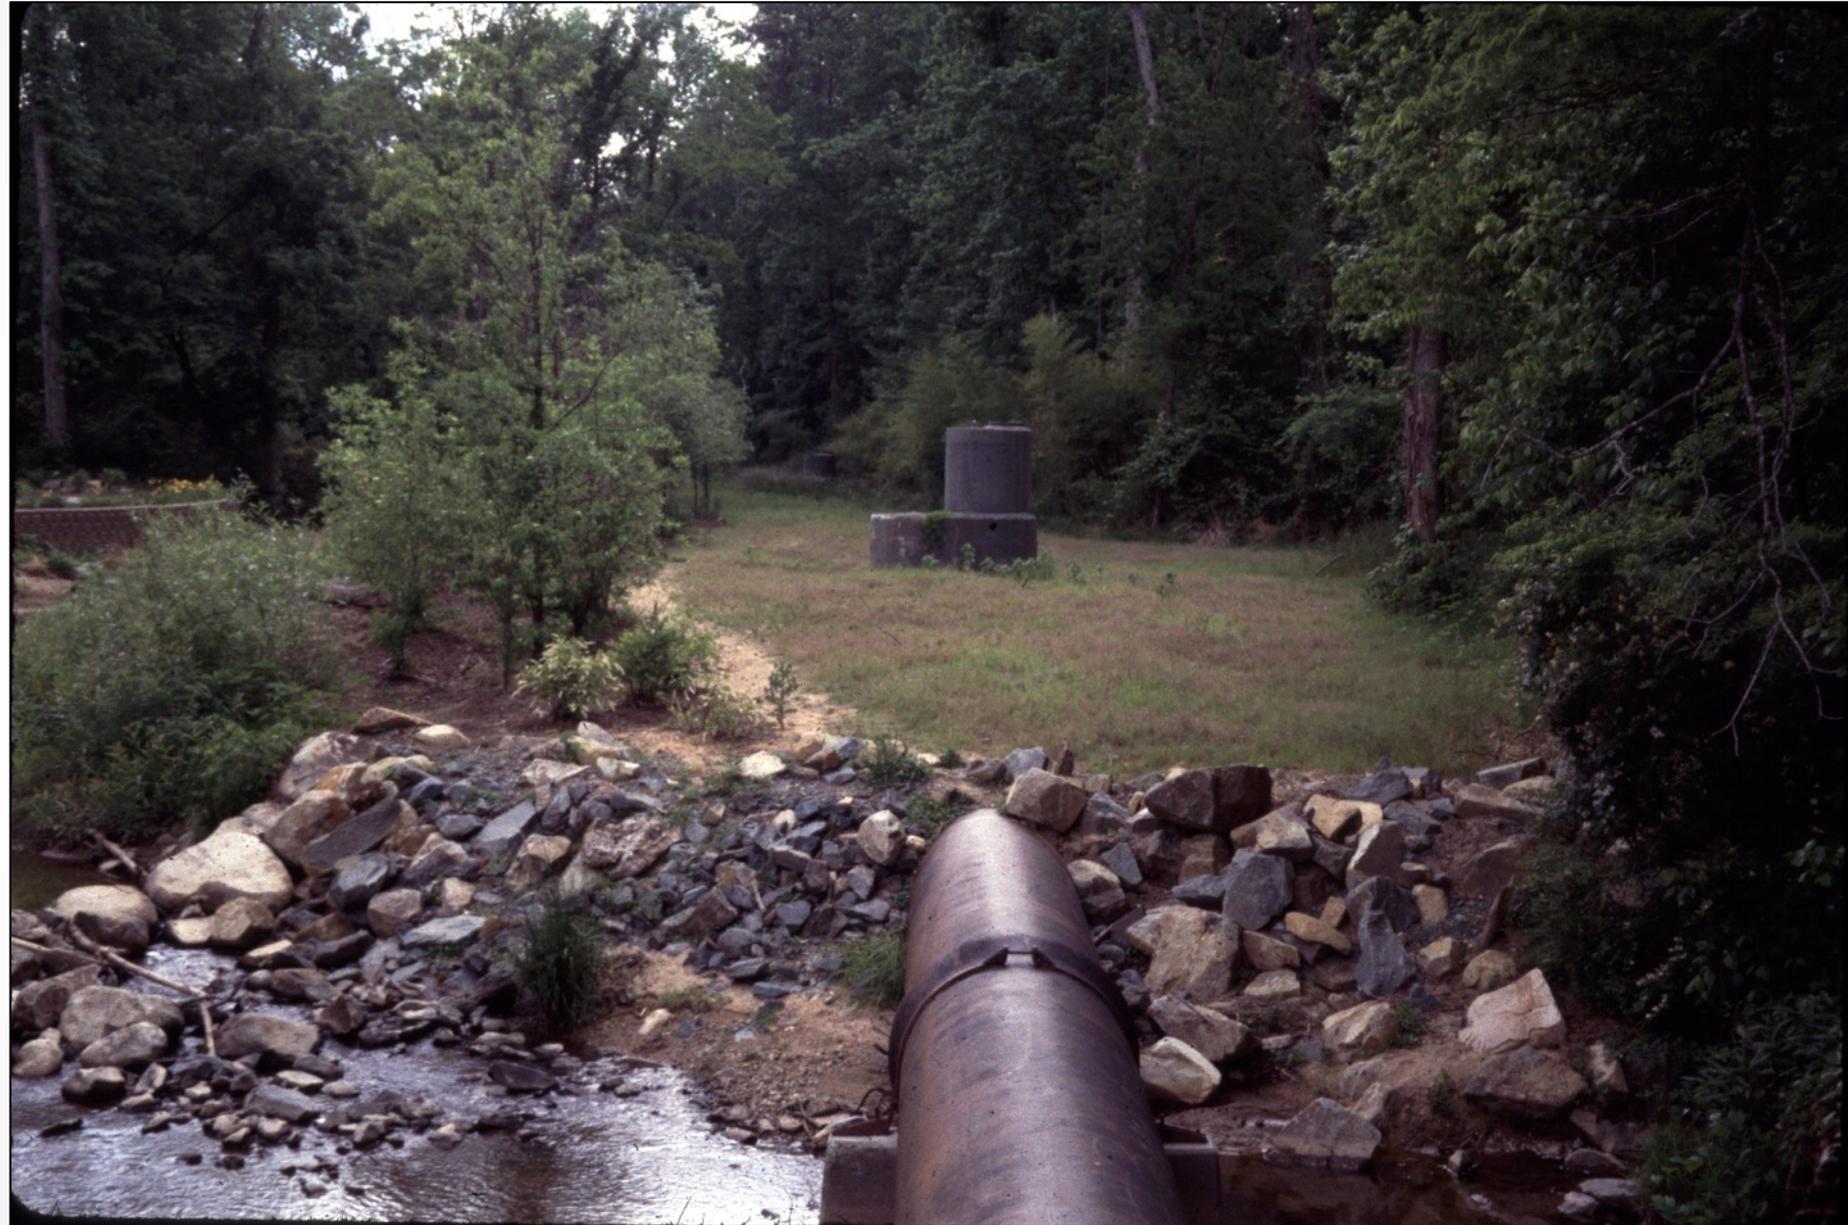
OWASA sewer pipe across Bolin creek: note cleared buffer due to easement for sewer

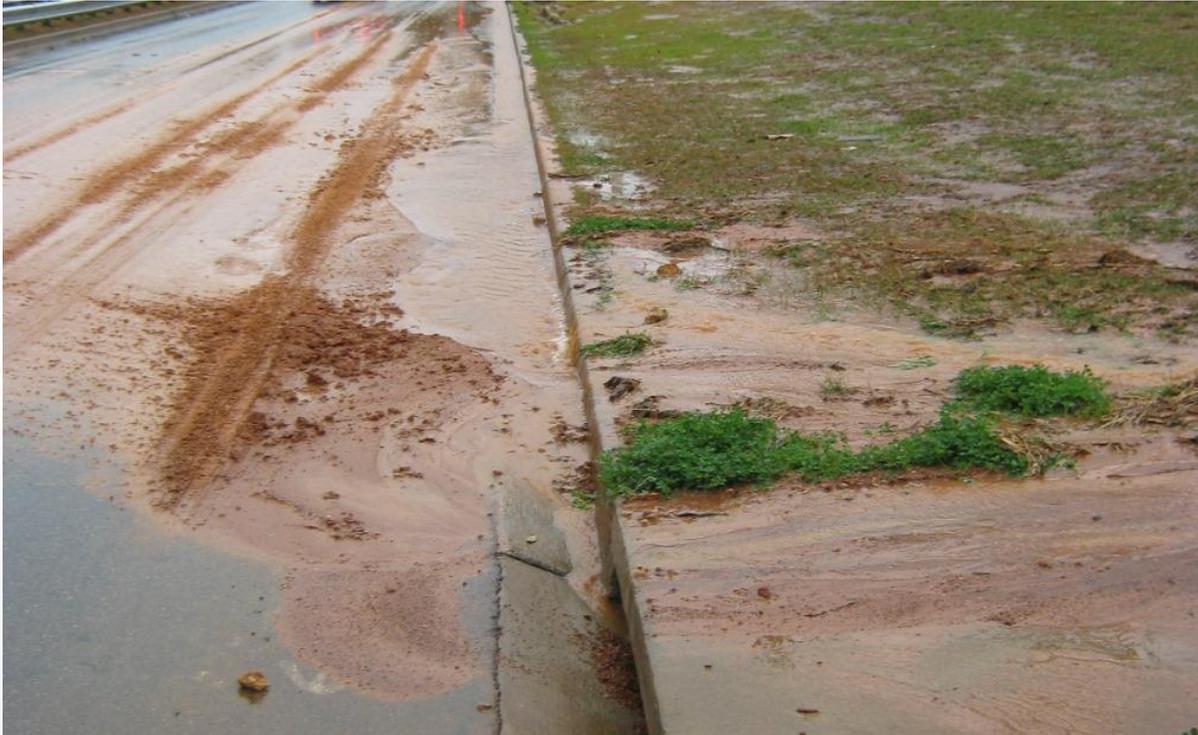
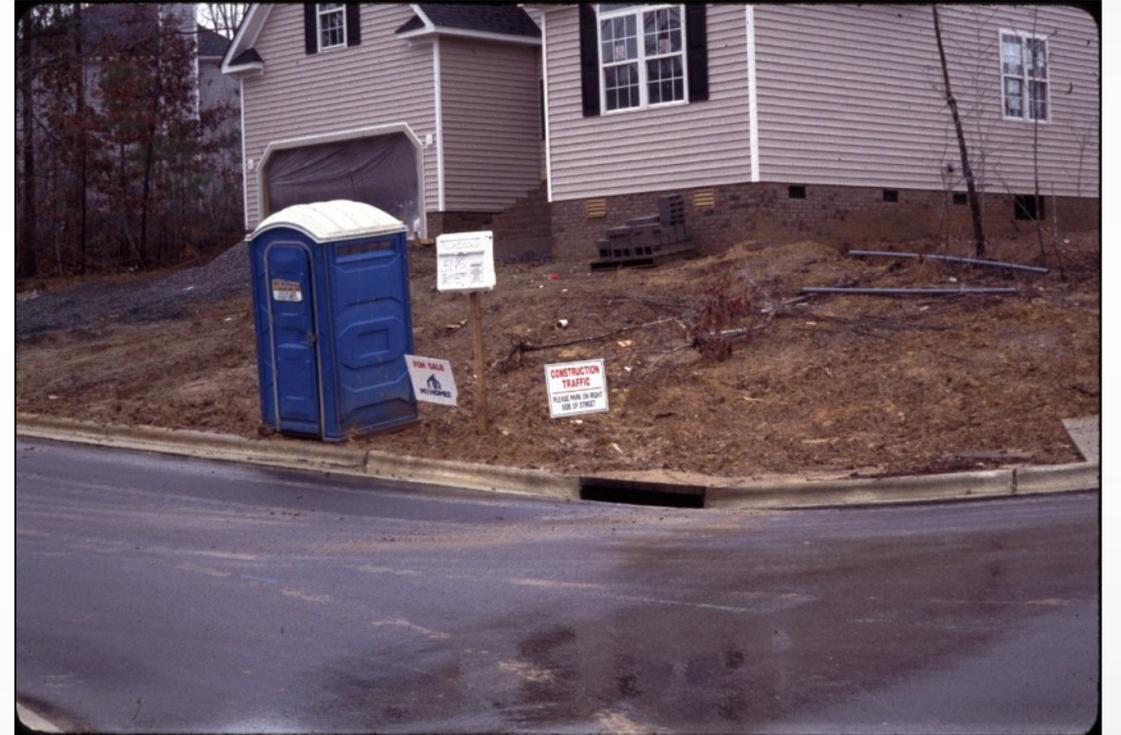
violation of stormwater erosion control ordinance: curb and gutter on Longmont street along Booker creek
