Todd BenDor
bendor@unc.edu

Sub-Watershed and Stream Evaluation

Thinking about Sub-watersheds

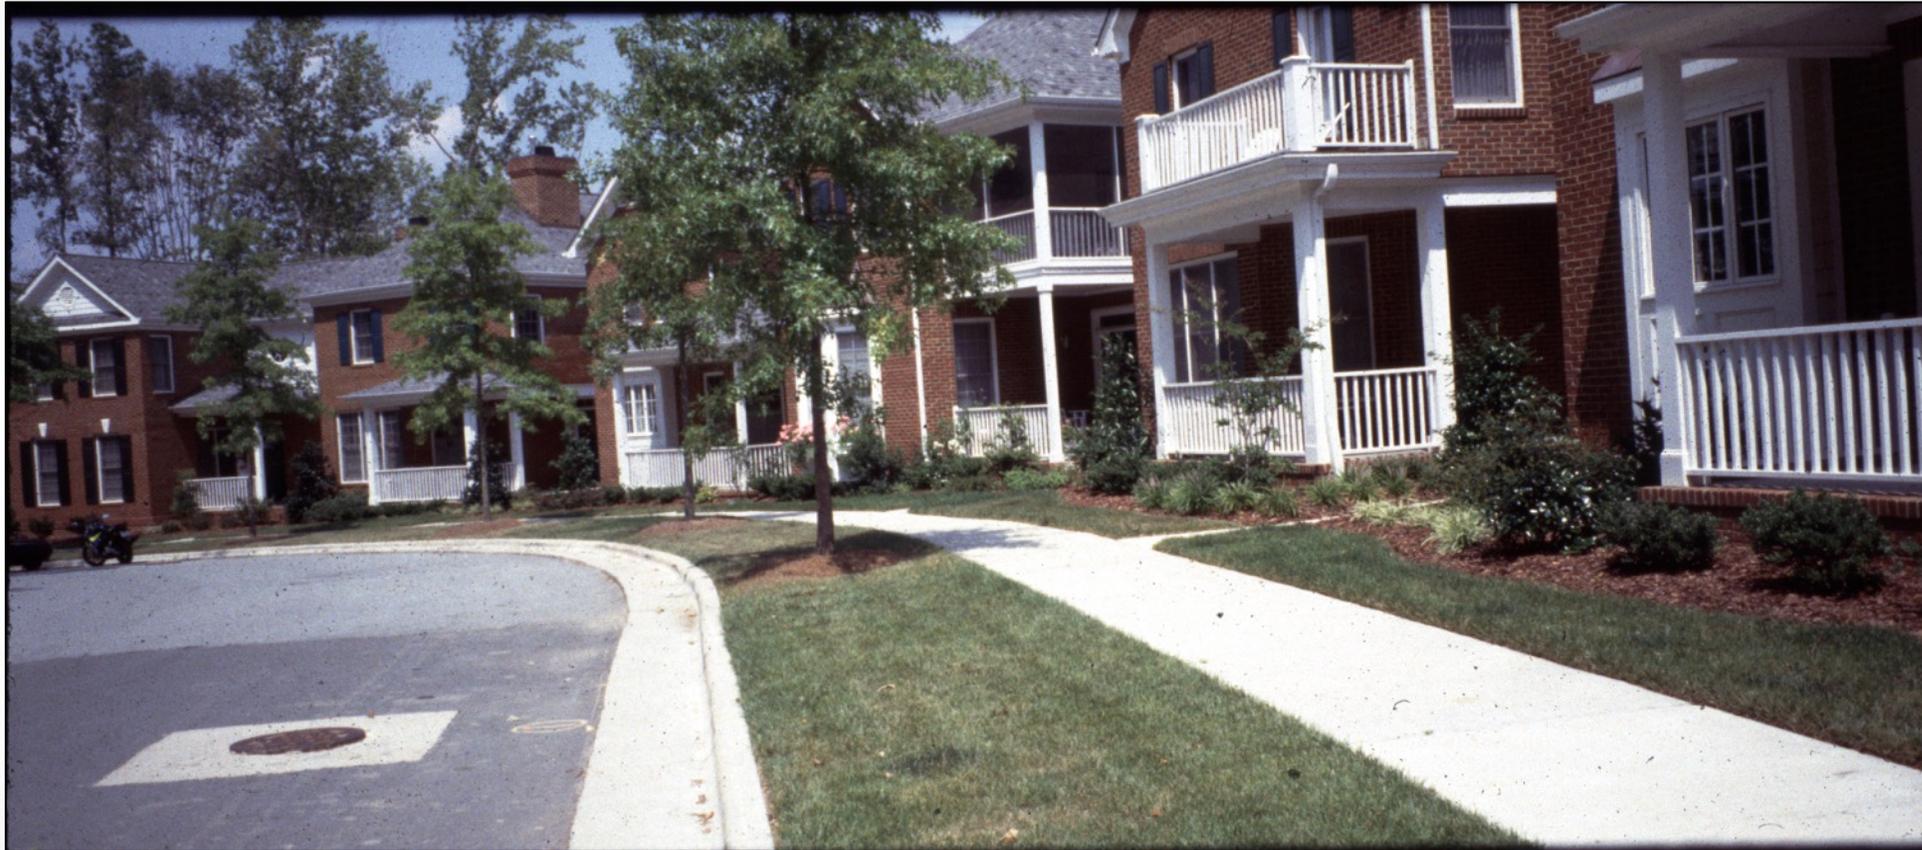
Vegetation island between street and sidewalk in Southern Village: could be improved if island converted to gentle sloping swale

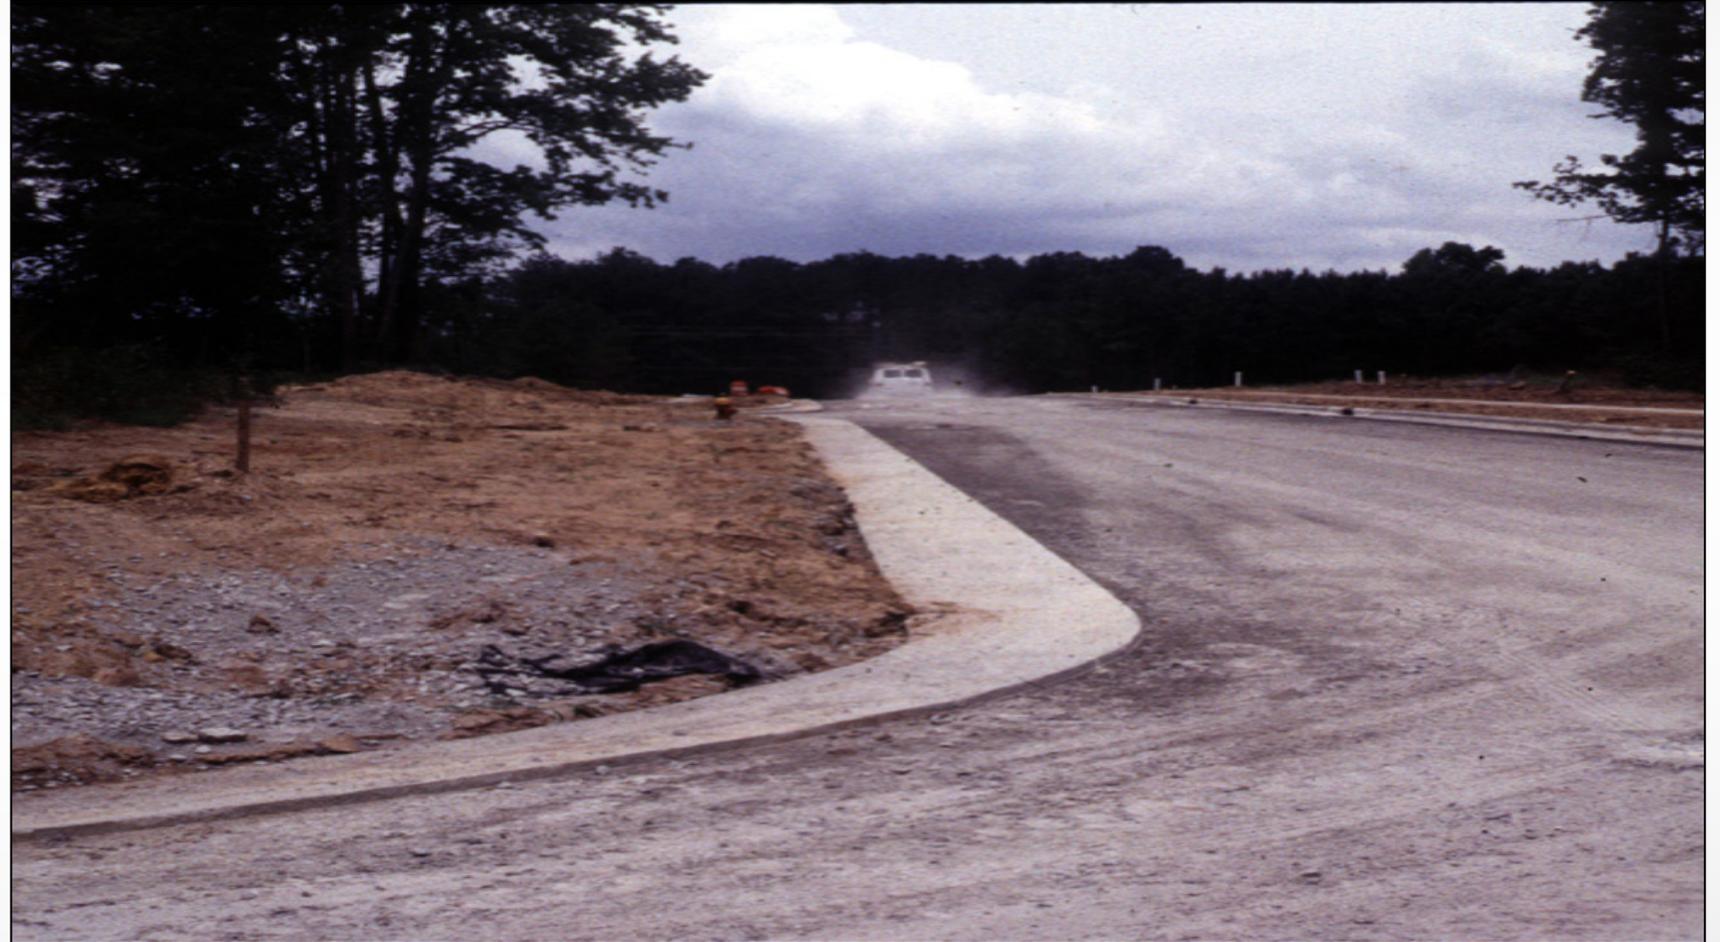
Flat (not raised) curbs used to promote sheet flow off streets onto grassy swales or into bioretention area in Carpenter Village, North Carolina.

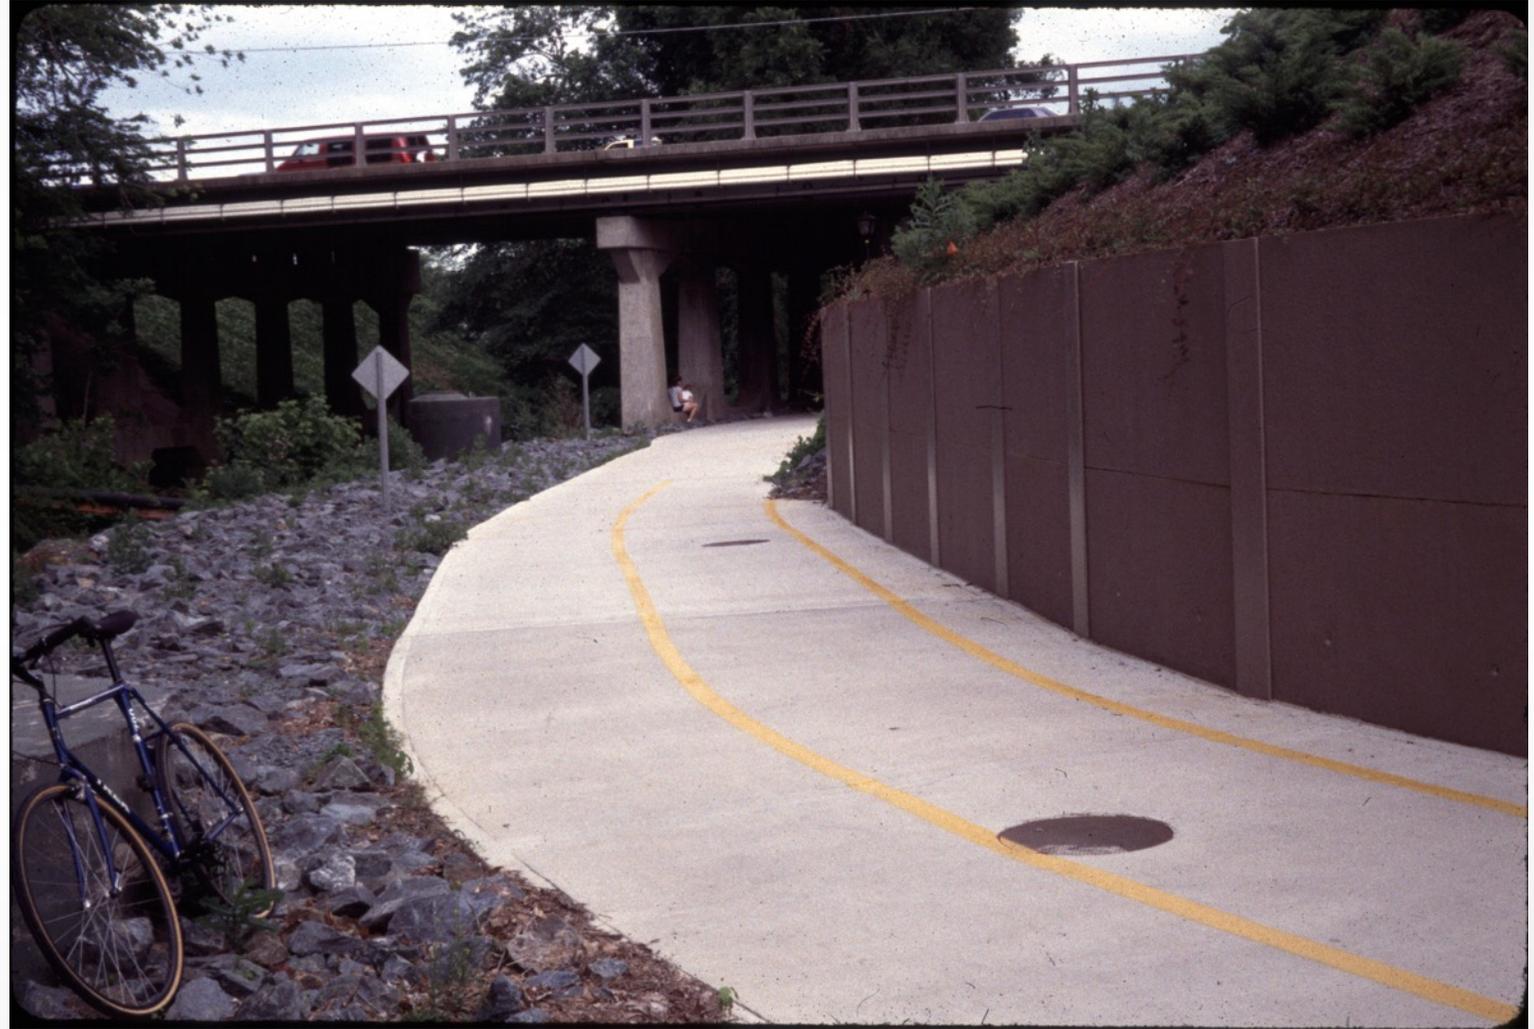
Social Environment: Restoration Project Below Sunrise Biscuit along Bolin Creek
